## SADHANA EDUCATION SOCIETY'S

(Registered under society's act of 1860 & Bombay Public Trust Act 1950)  
Linguistic (Gujarati) Minority

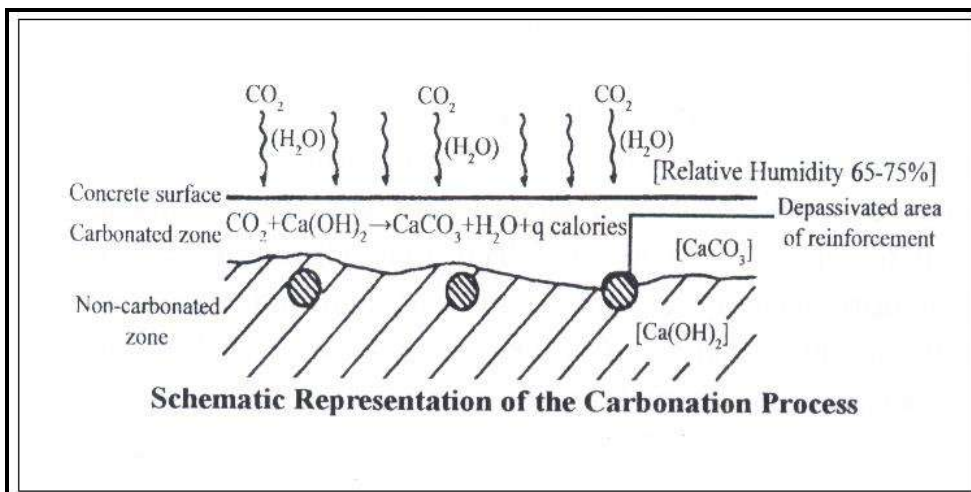
# OBSERVED DEFECTS AND DISTRESS SYMPTOMS WITH PHOTOGRAPHS

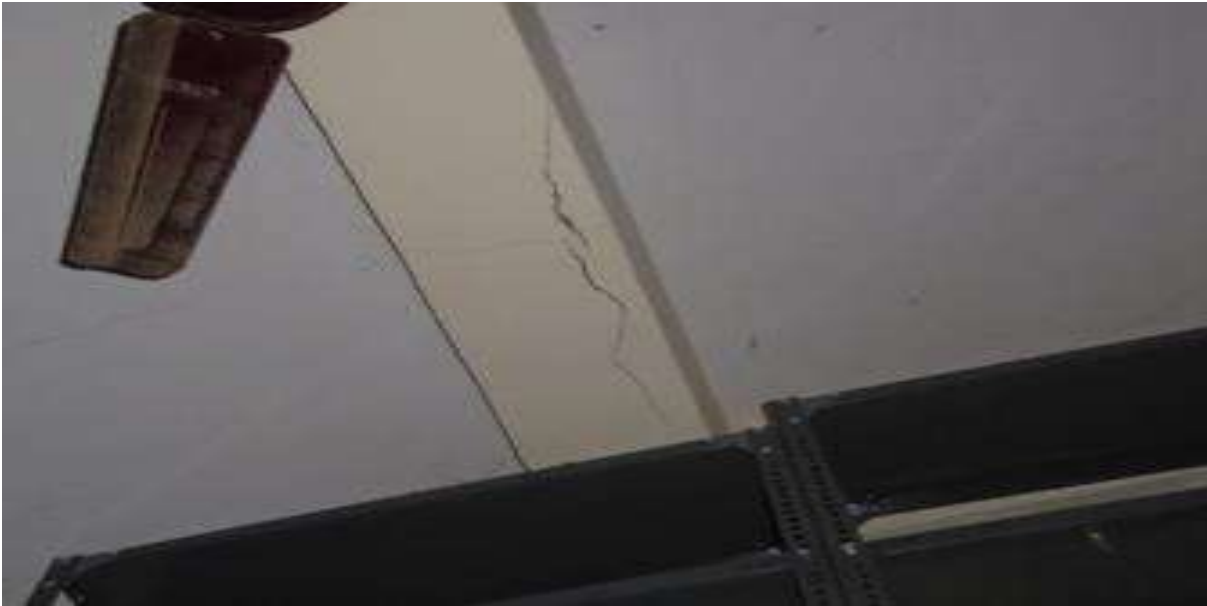
PH NO-01:-Photograph showing crack on beam bottom at staircase area.

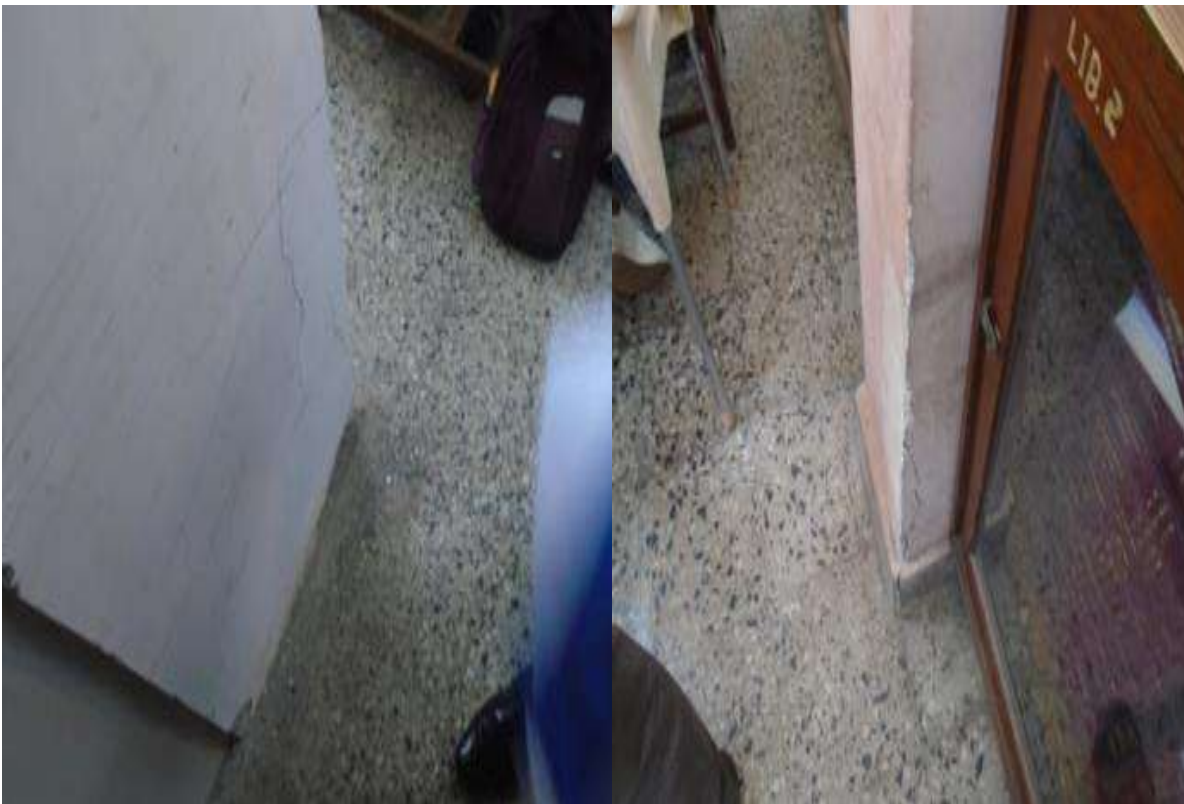
PH NO-03 & 04:-Photograph showing crack on column bottom at office no-27.

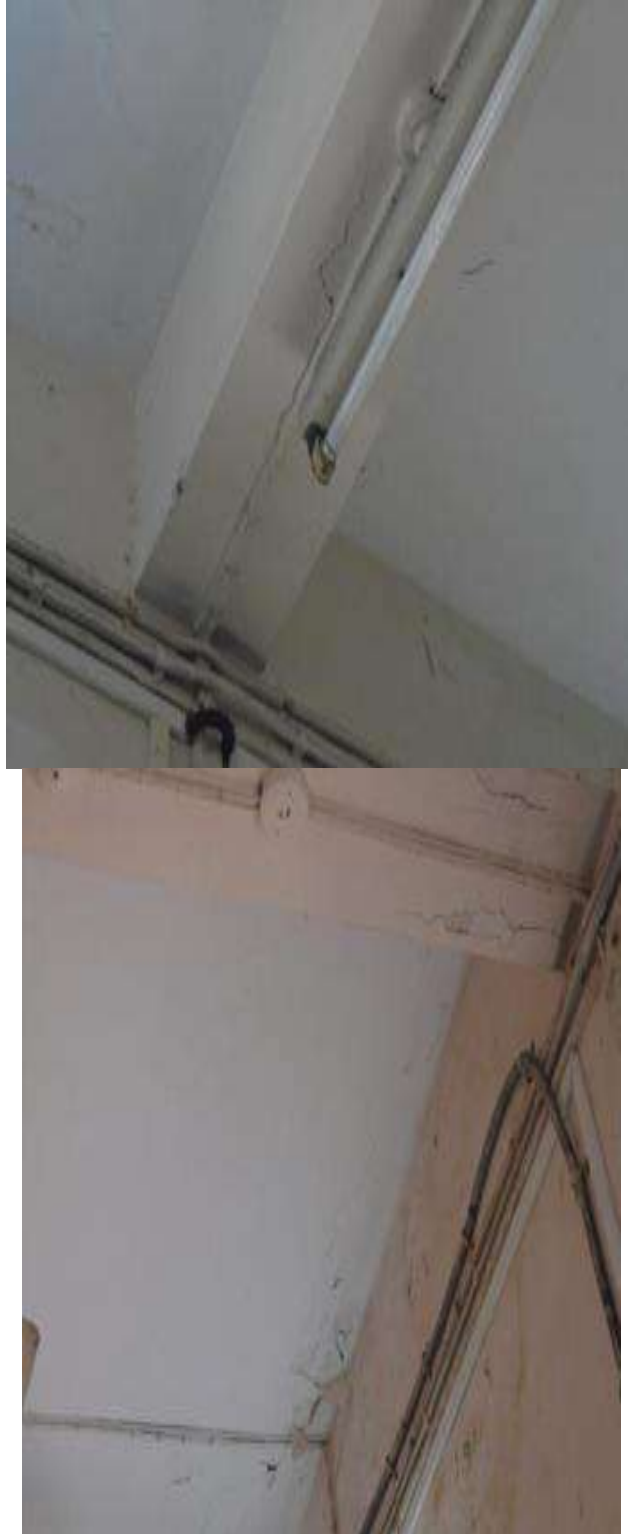
PH NO-05 & 06:-Photograph showing cracks on beam at office no -27.

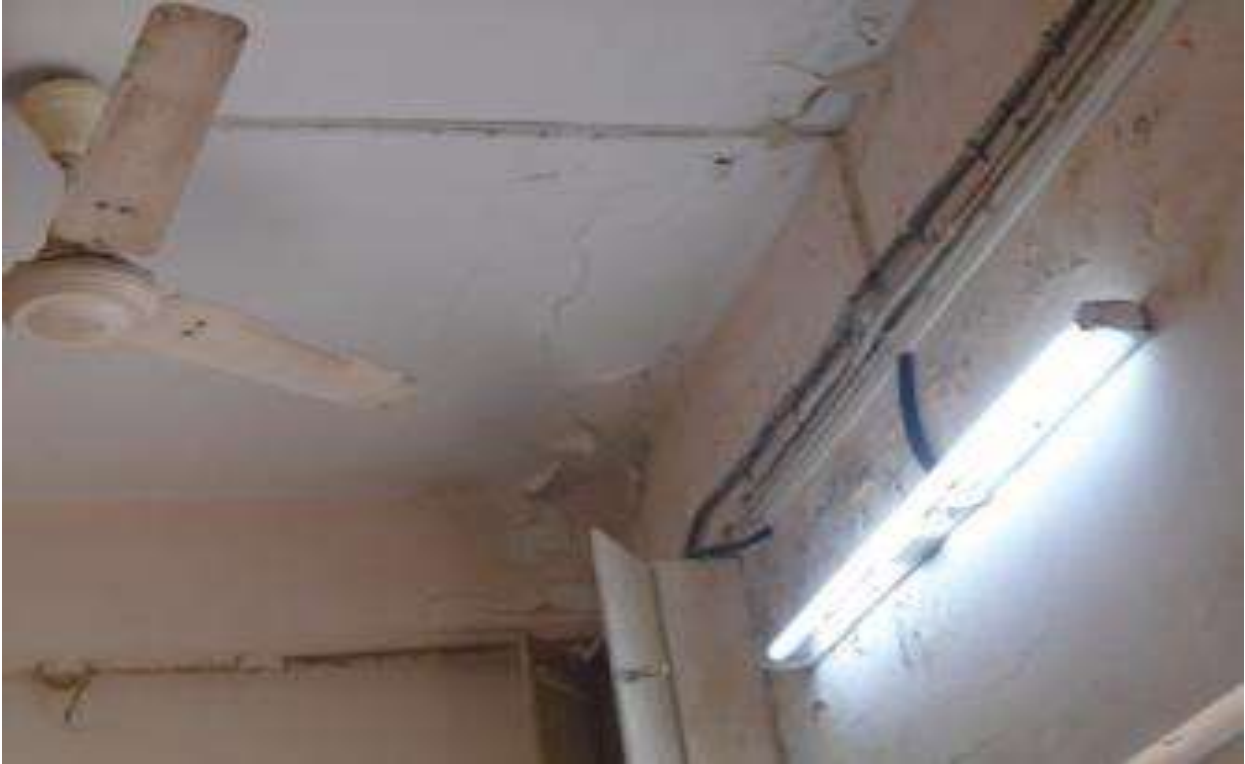
PH NO-07:-Photograph showing crack on slab.

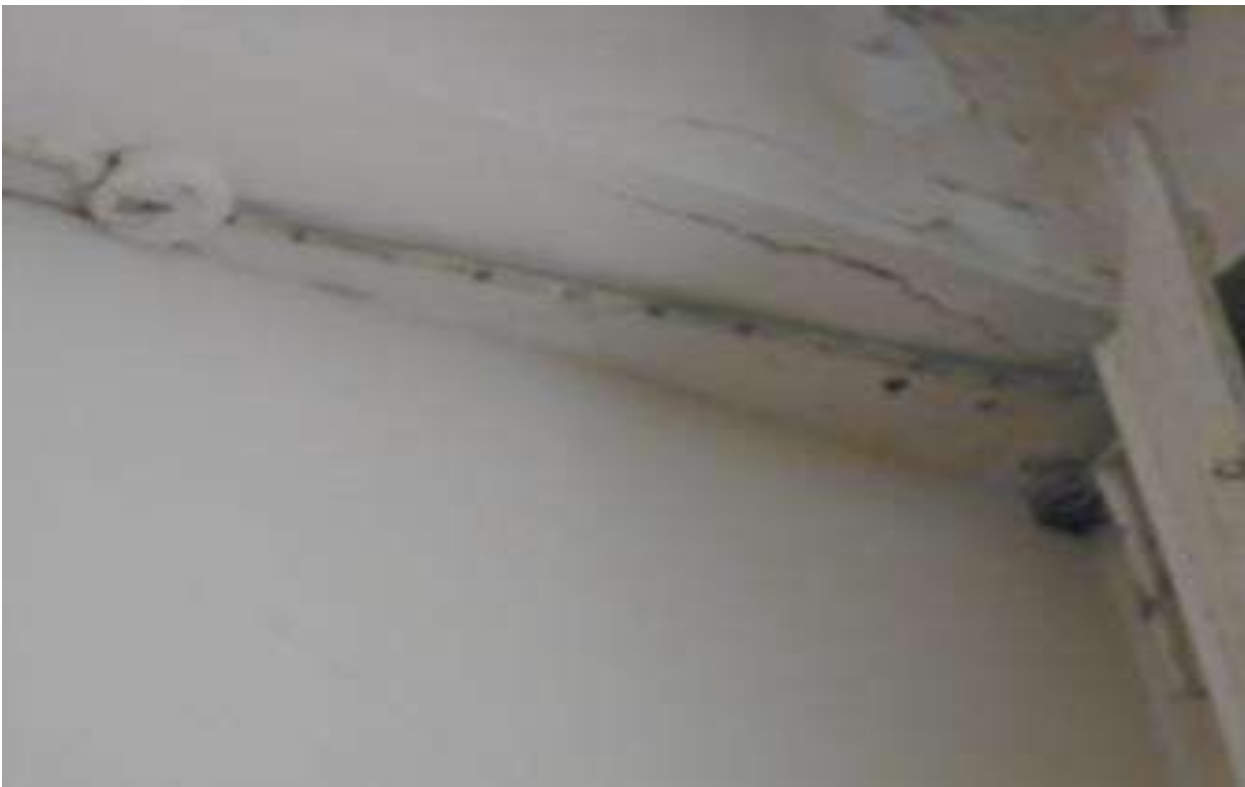
PH NO-09:-Photograph showing crack on beam.

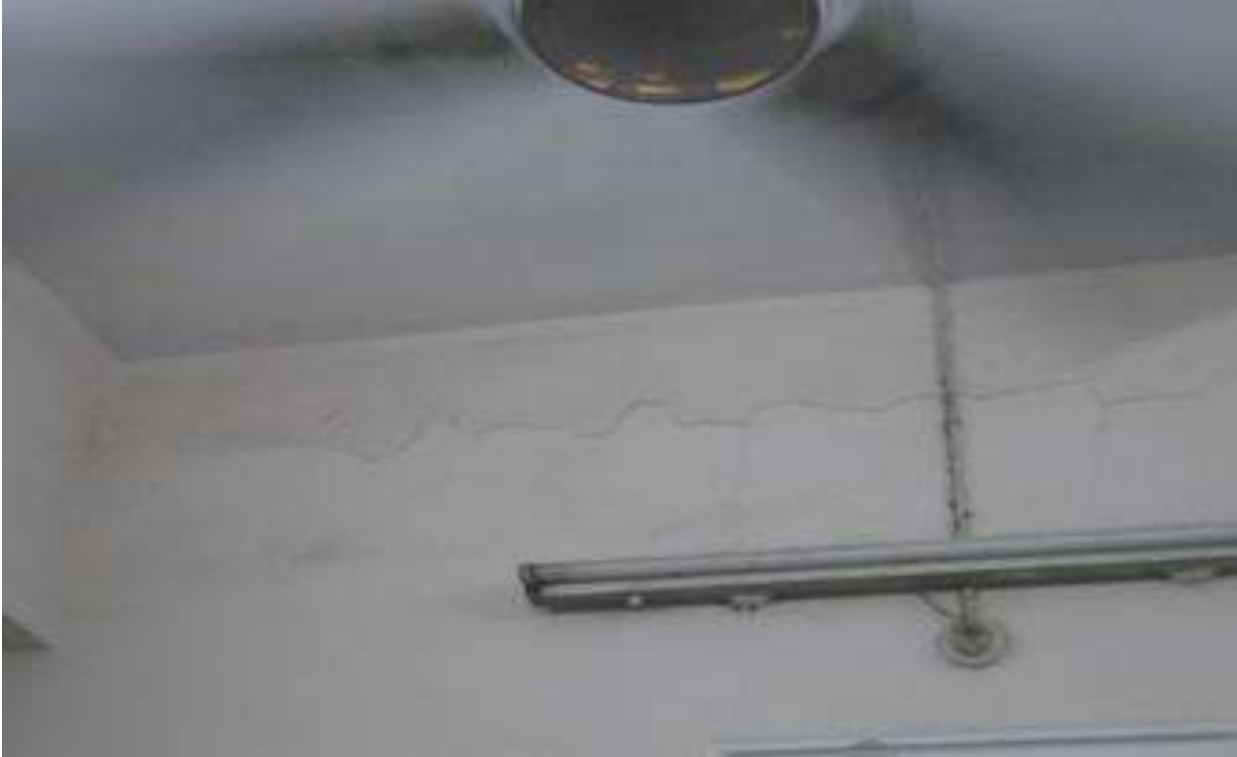
PH NO-10:-Photograph showing crack on beam at office no- 24.

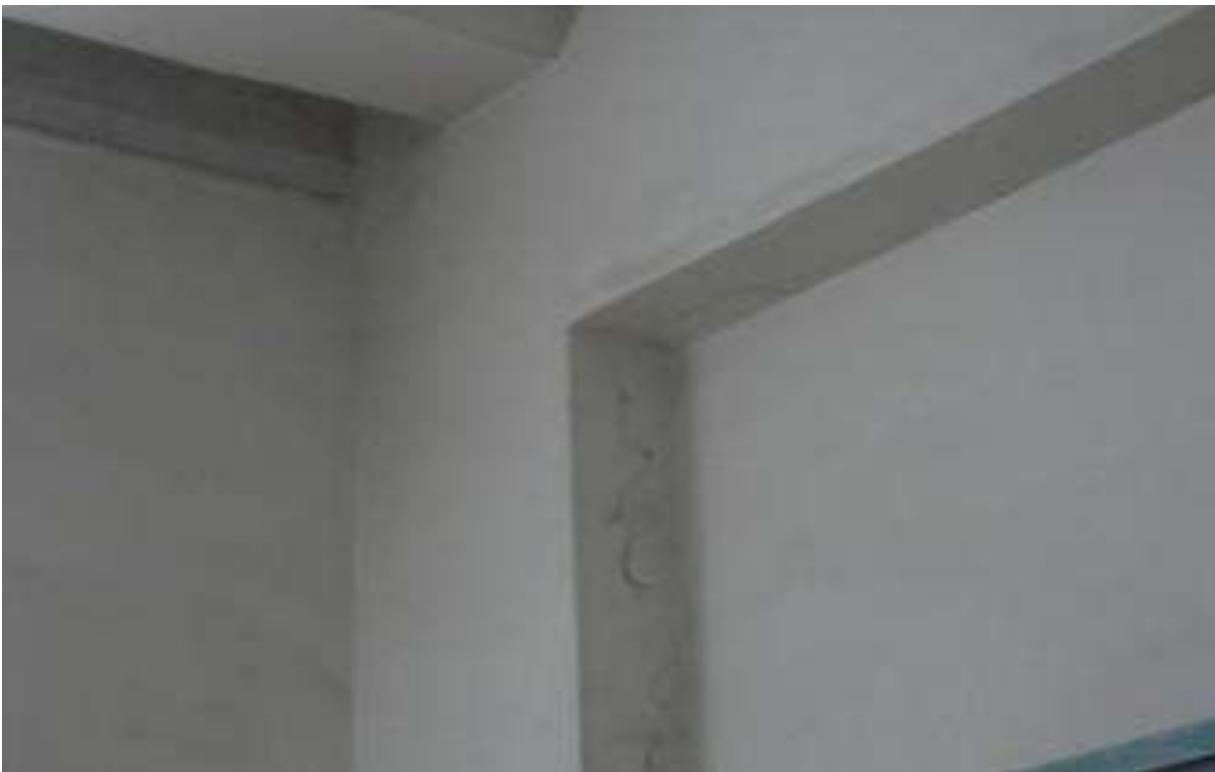
PH NO-11:-Photograph showing crack on column at office no- 24.

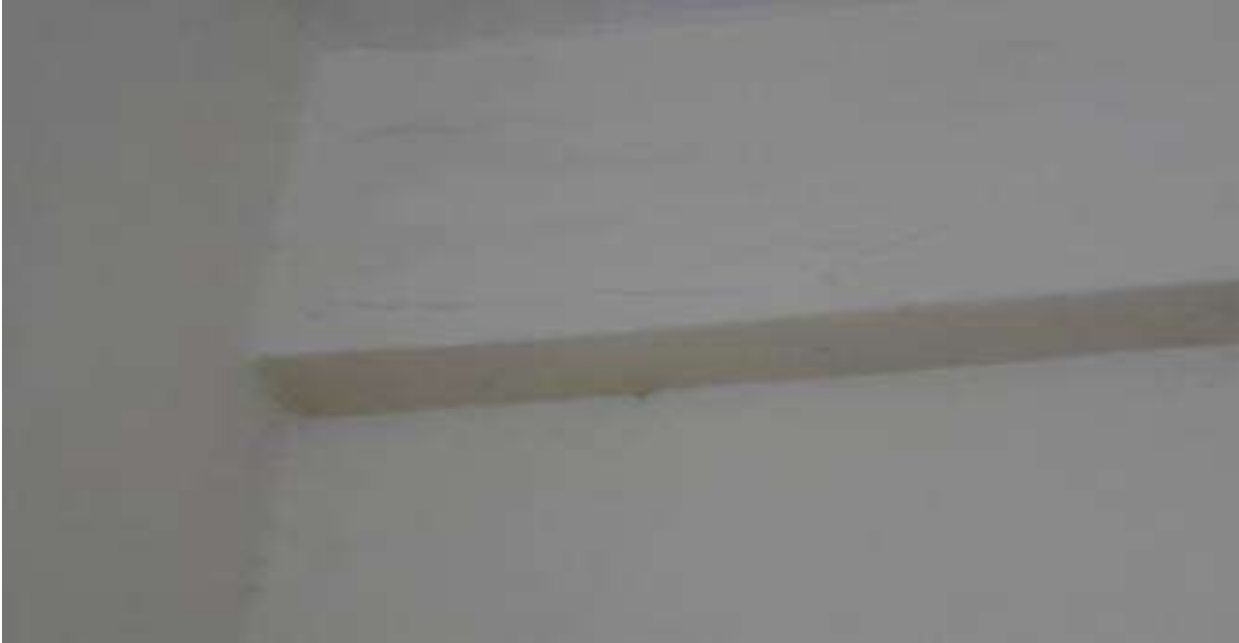
PH NO-12:-Photograph showing crack on beam at passage.

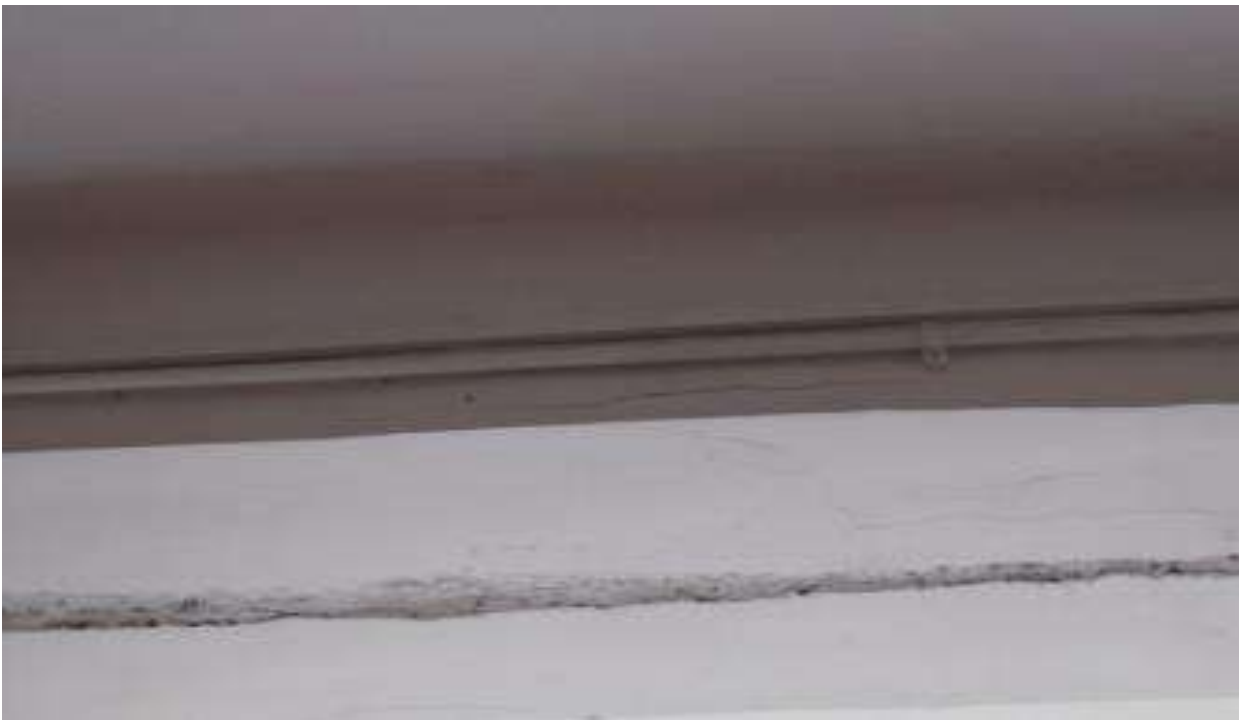
PH NO-13:-Photograph showing crack on beam at passage.

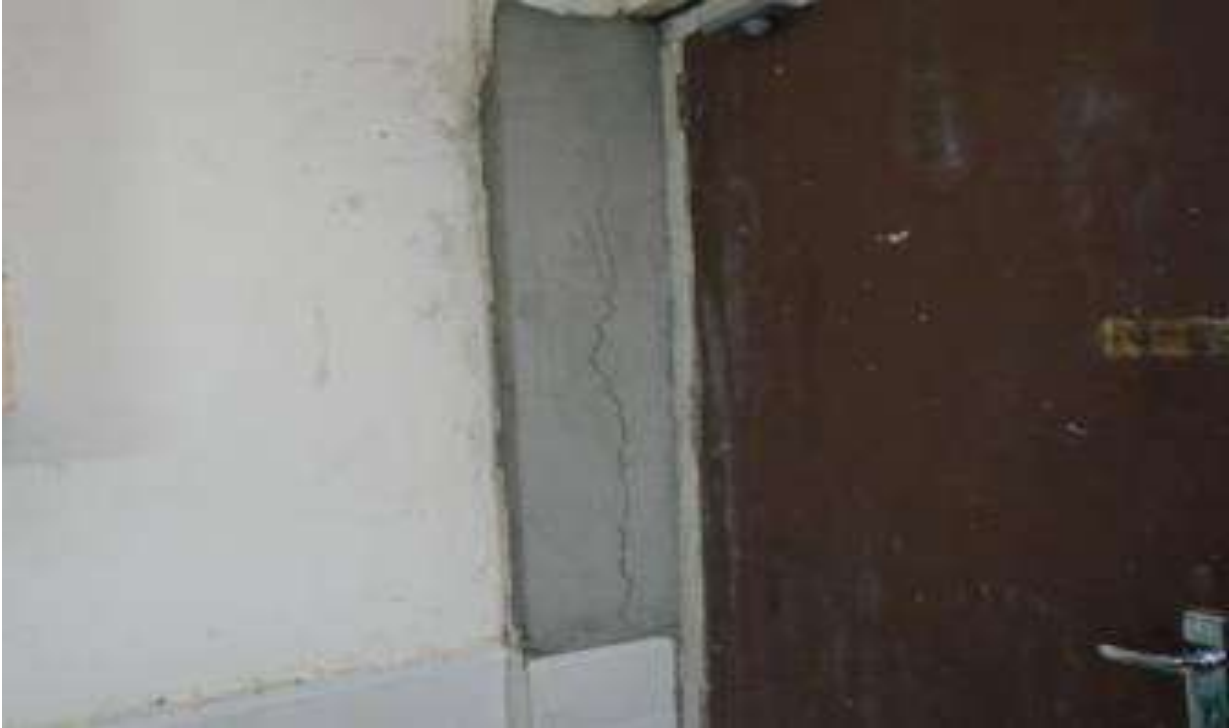
PH NO-14:-Photograph showing crack on column at office no- 32.

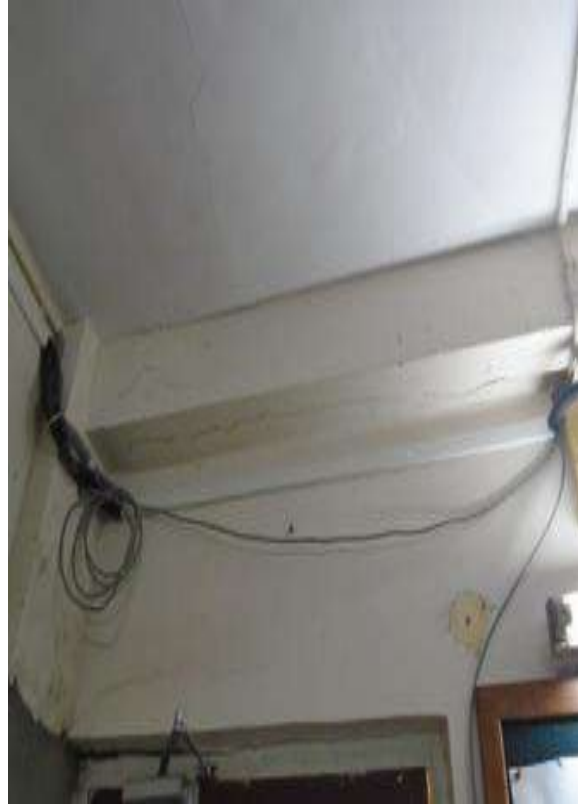
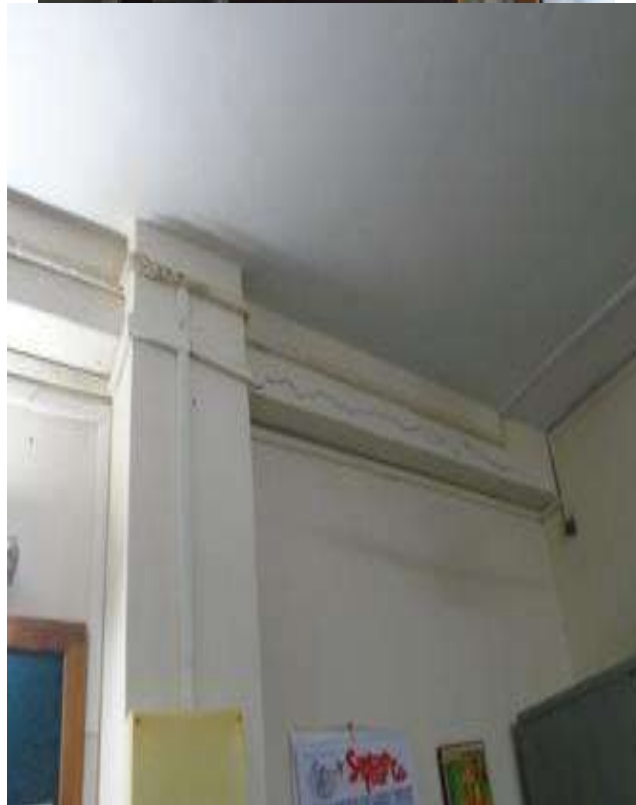
PH NO-15 & 16:-Photograph showing crack on beam at office no- 32.

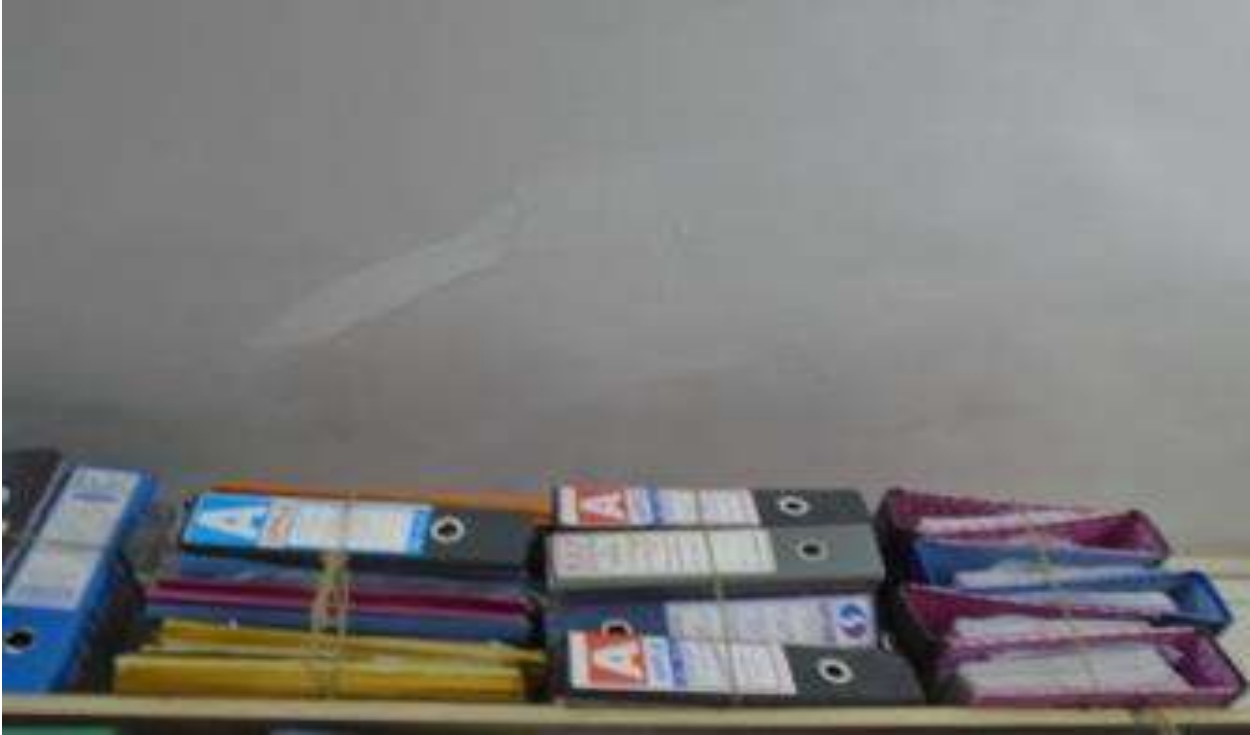
PH NO-17:-Photograph showing bulge concrete cover on slab at office no- 32.

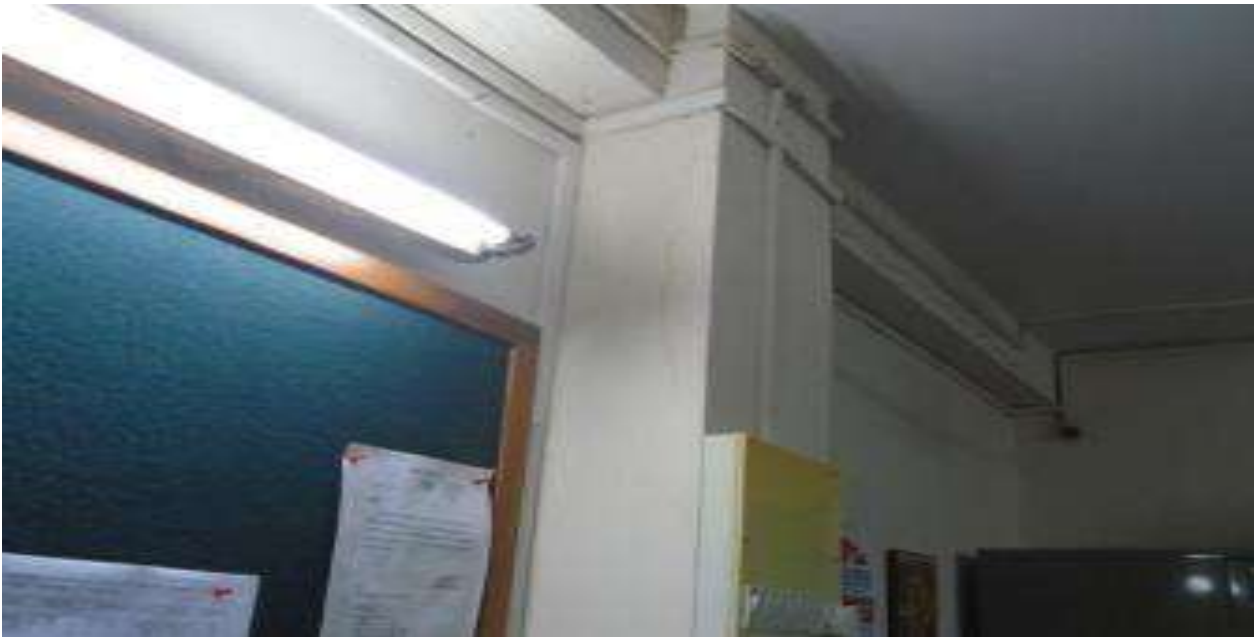
PH NO-18:-Photograph showing crack on column.

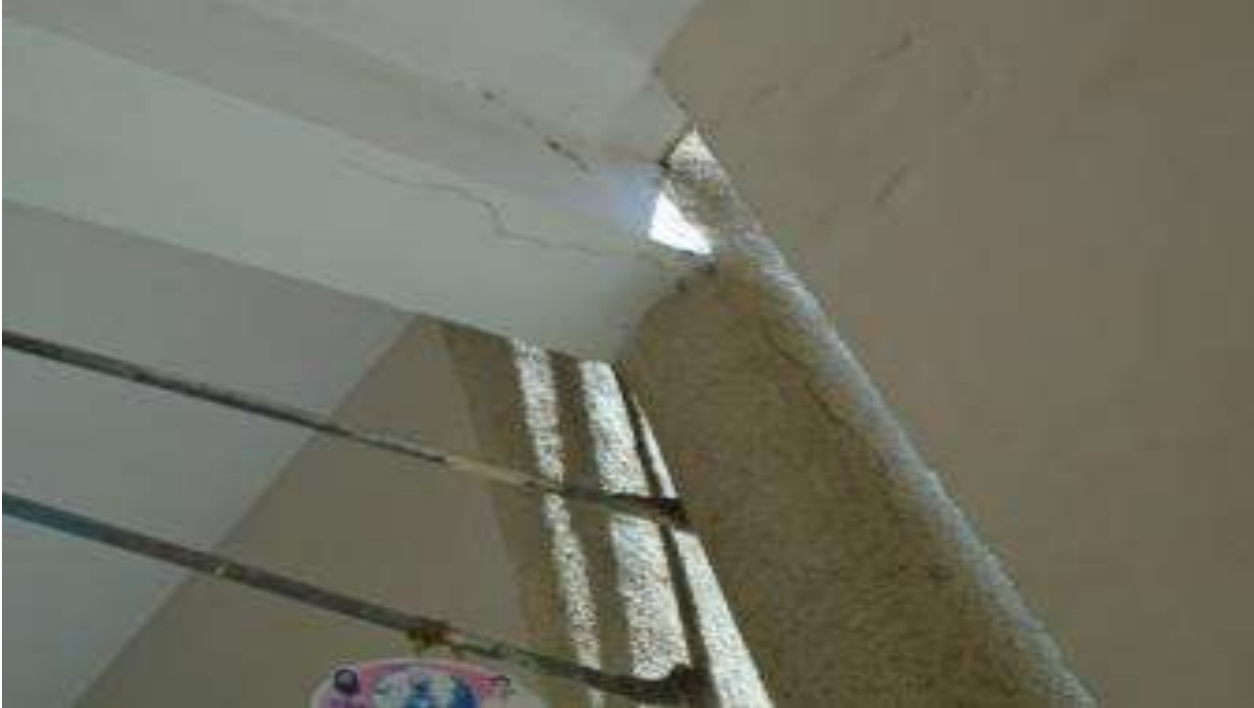
PH NO-19:-Photograph showing crack on column and beam at various locations of passage.

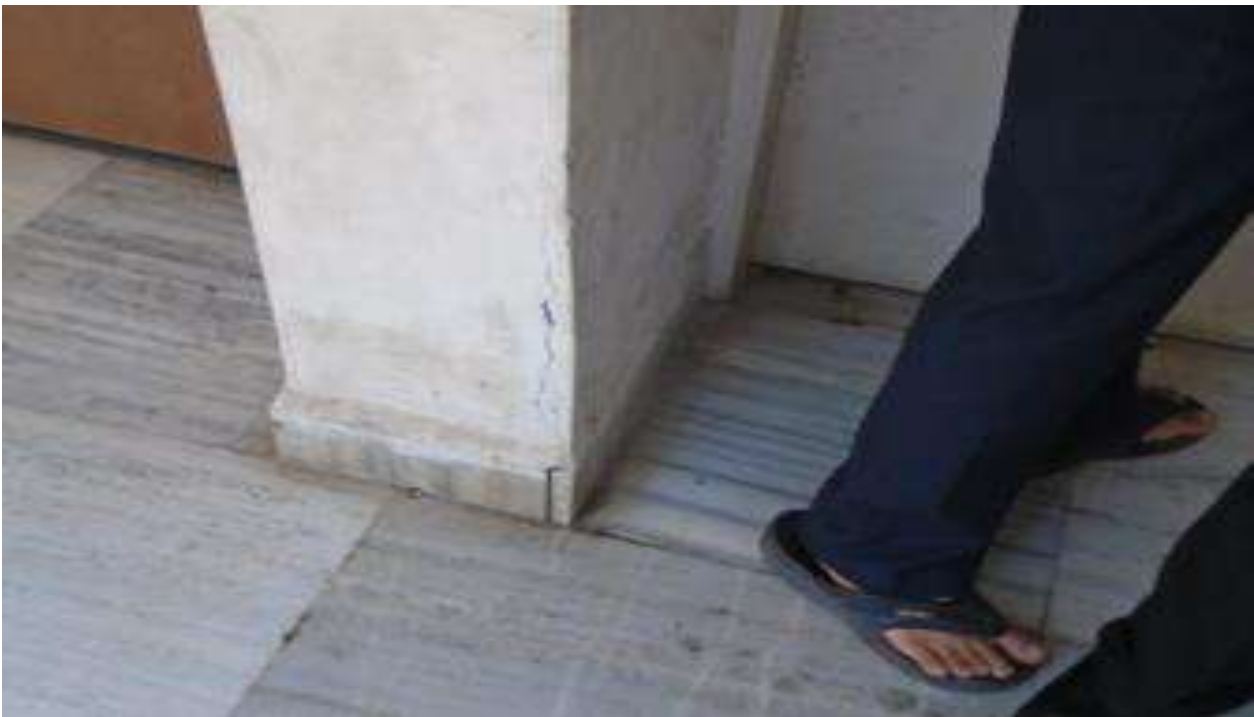
PH NO-20:-Photograph showing crack on column at various locations of passage.

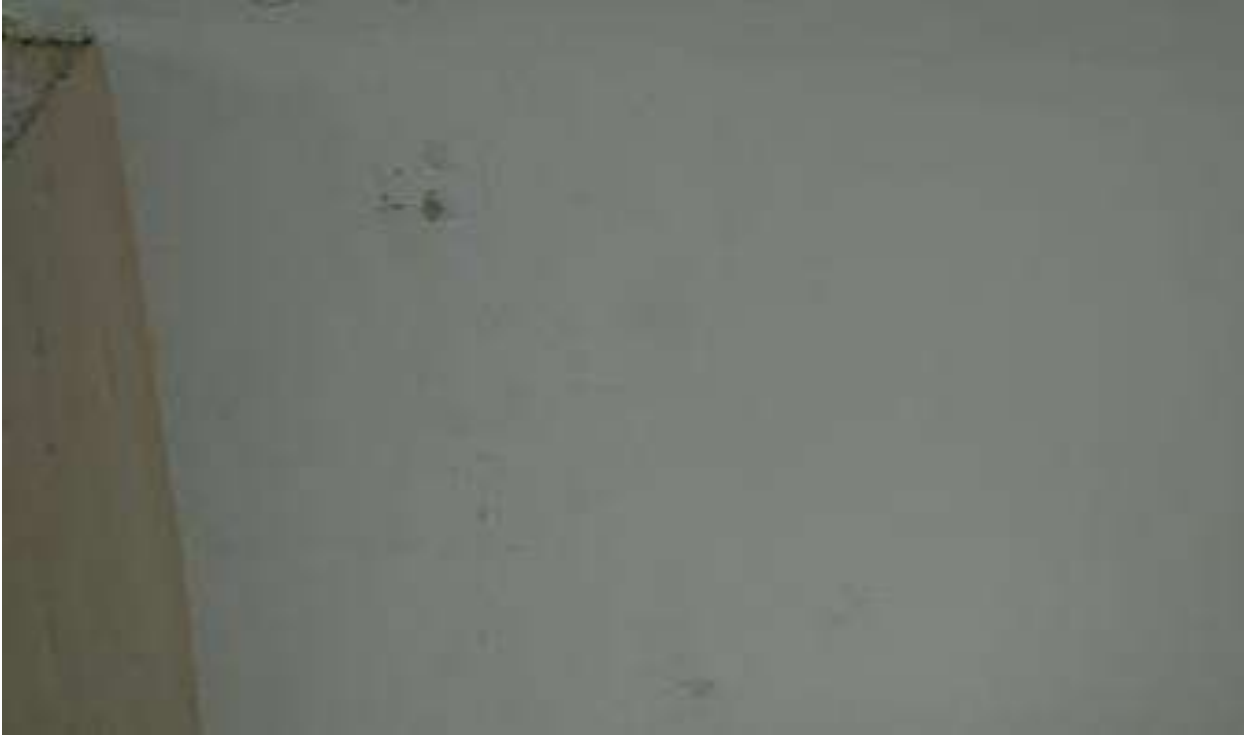
PH NO-21:-Photograph showing de bonded concrete cover on slab.

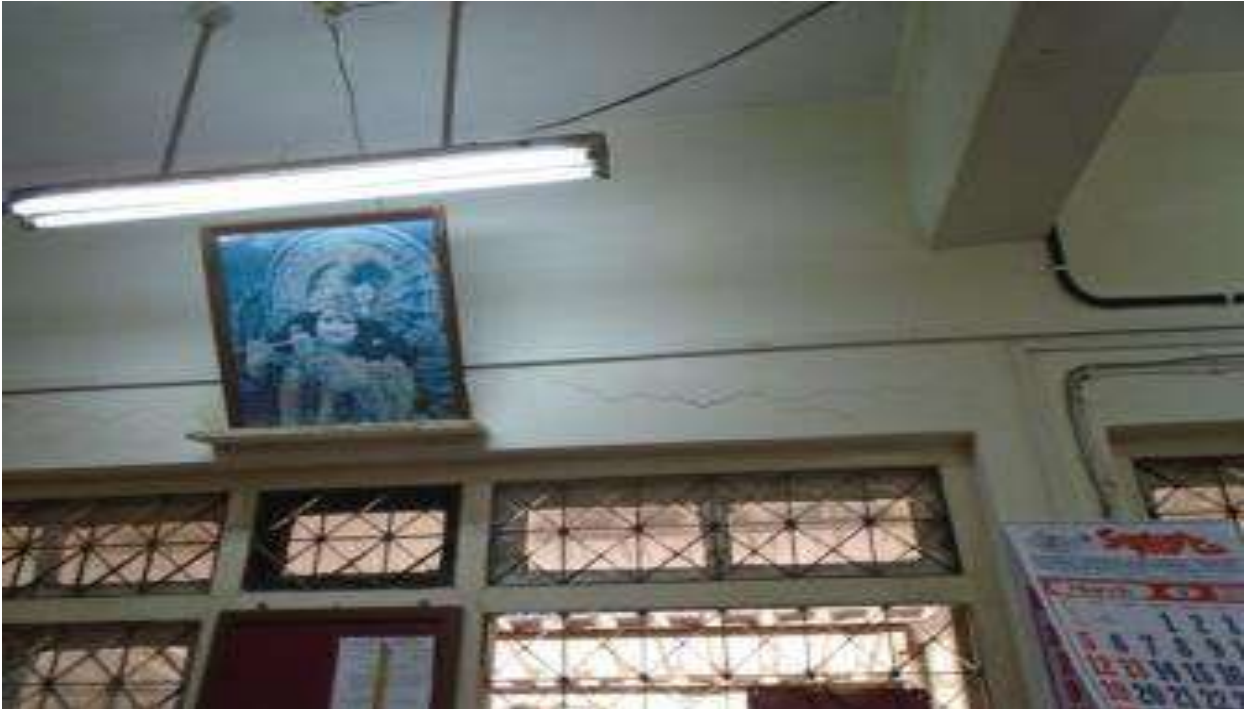
PH NO-22:-Photograph showing crack on lintel beam above window at office no-13.

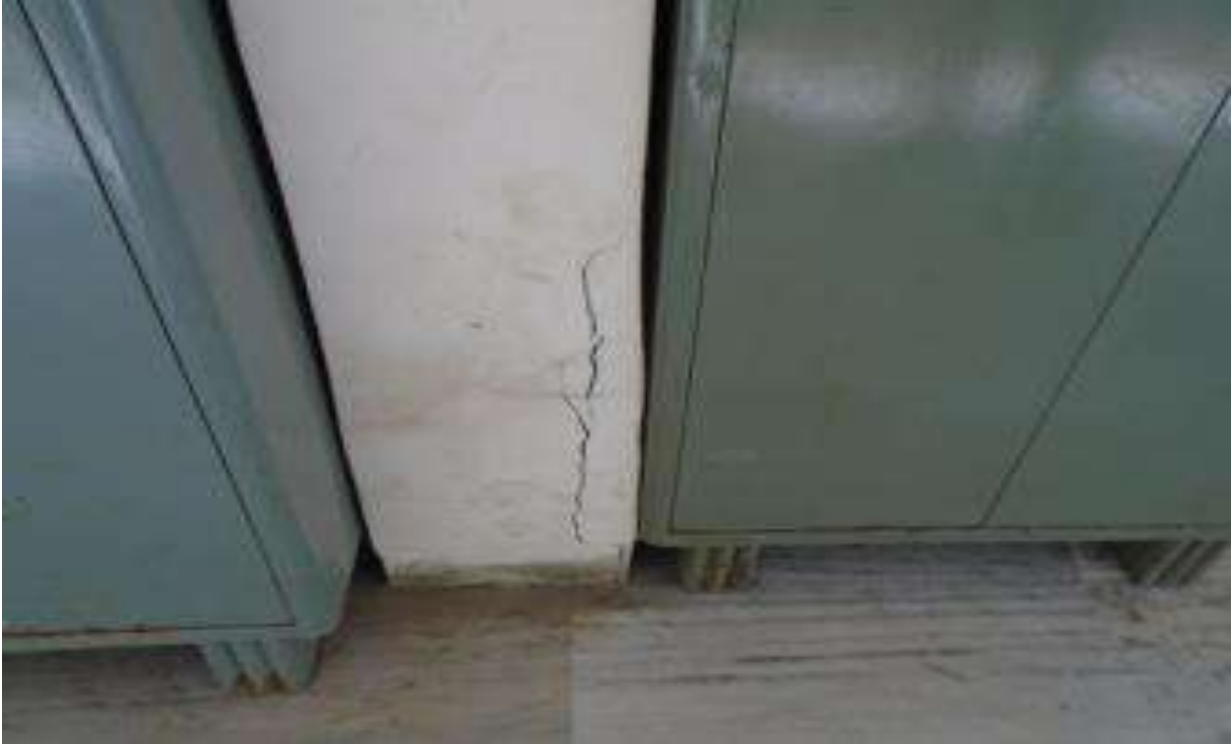
PH NO-23:-Photograph showing crack on column.

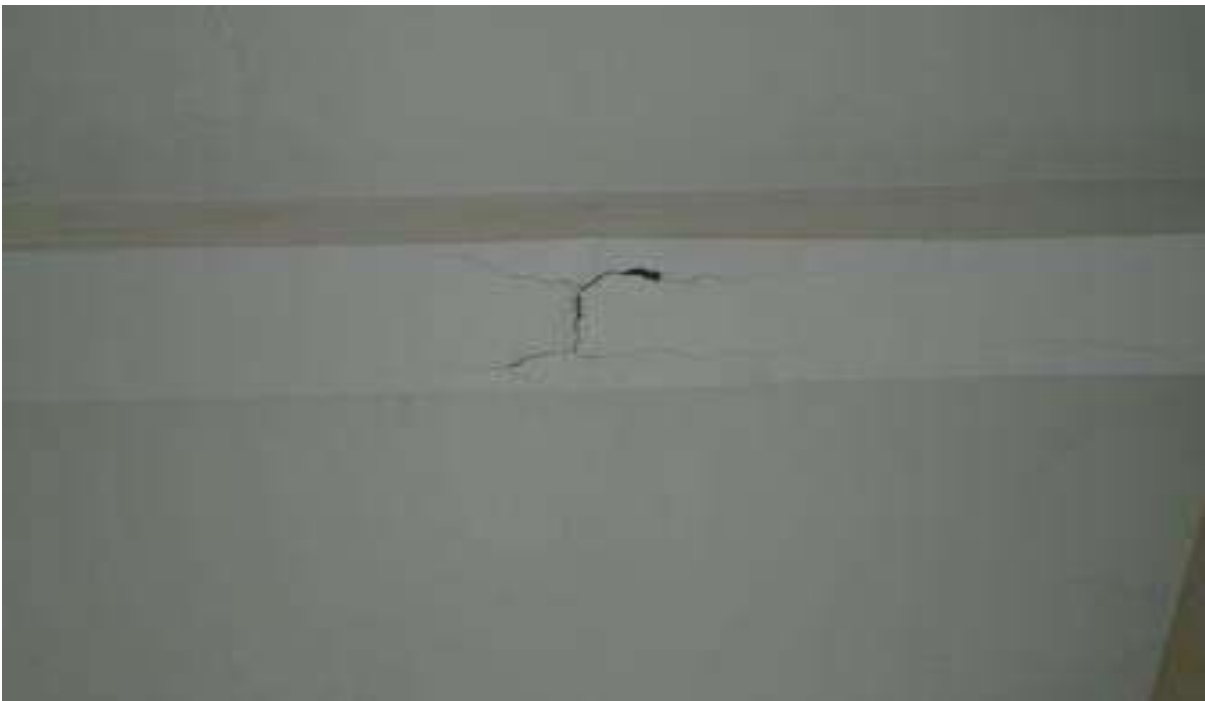
PH NO-24:-Photograph showing bulge concrete cover on beam bottom.

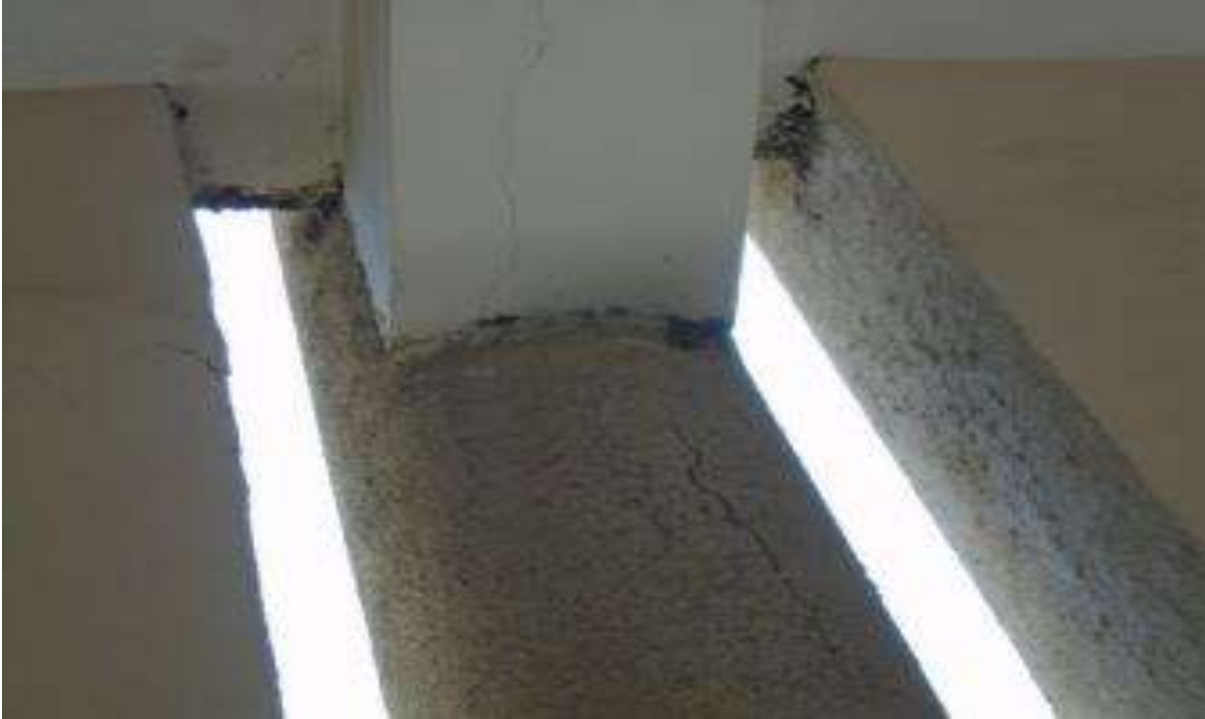
PH NO-25:-Photograph showing crack on column and beam at passage.

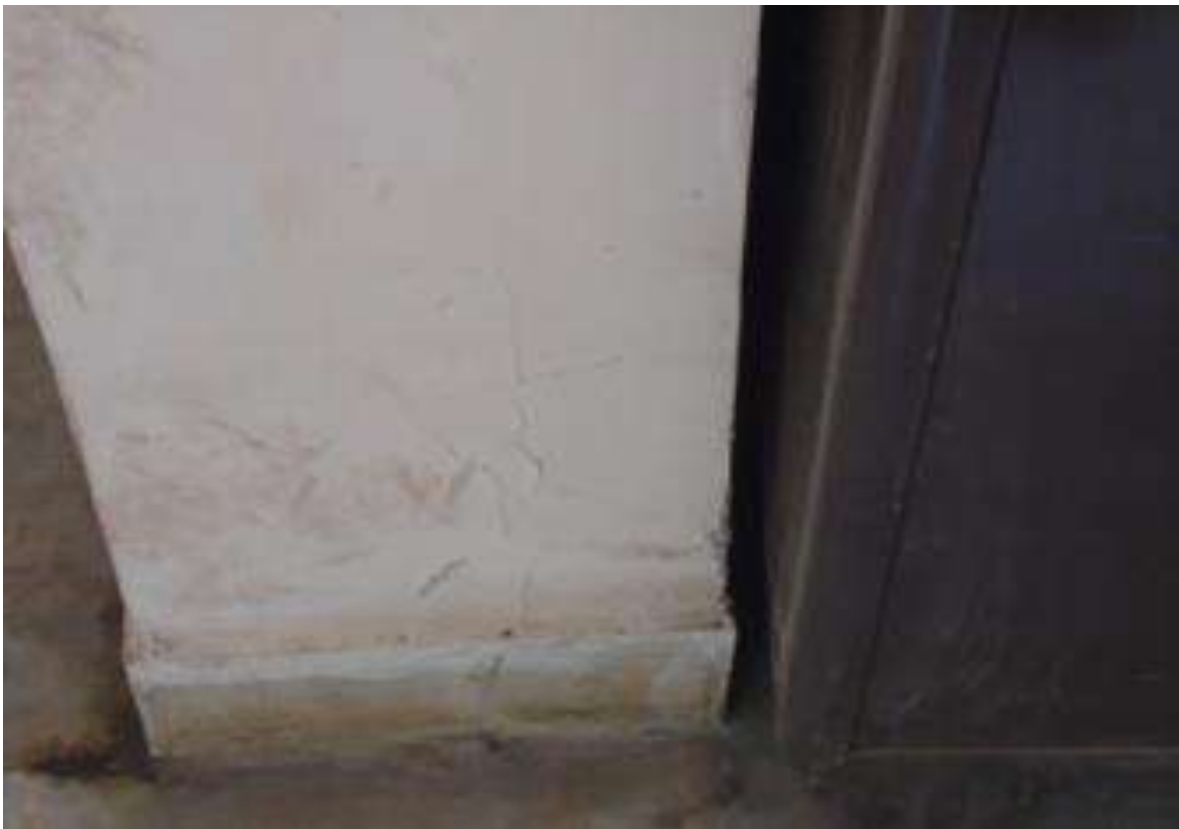
PH NO-26:-Photograph showing crack on column at passage.

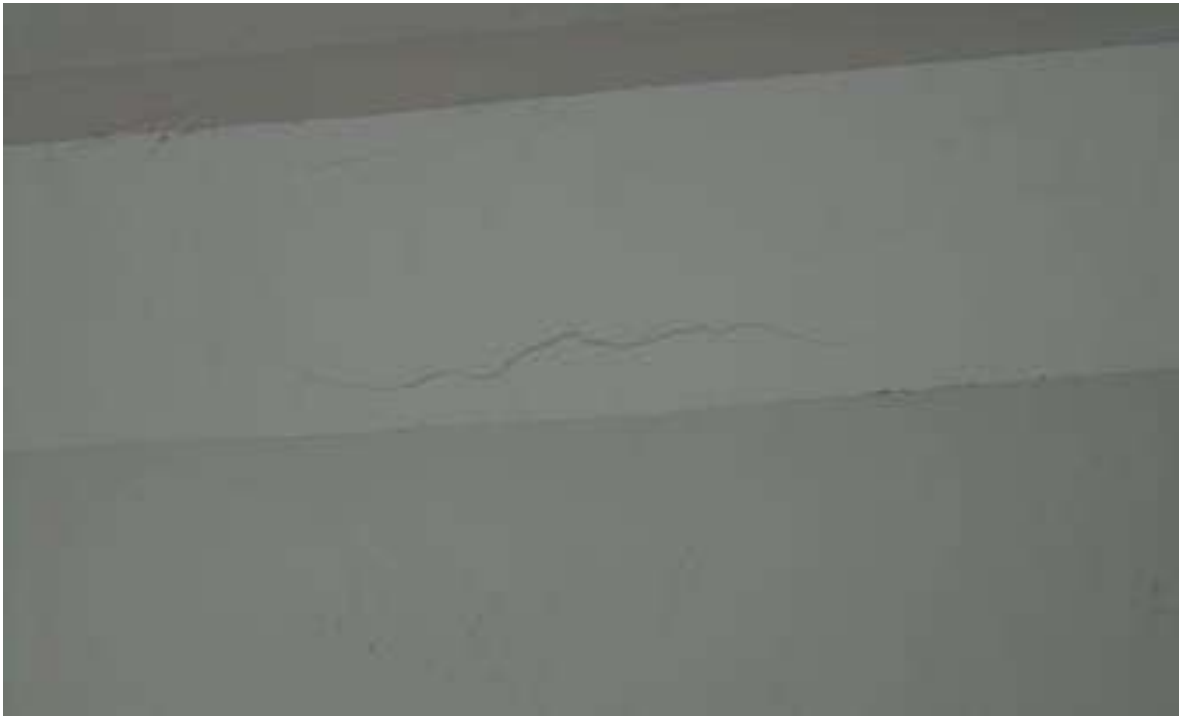
PH NO-27:-Photograph showing crack on beam at passage.

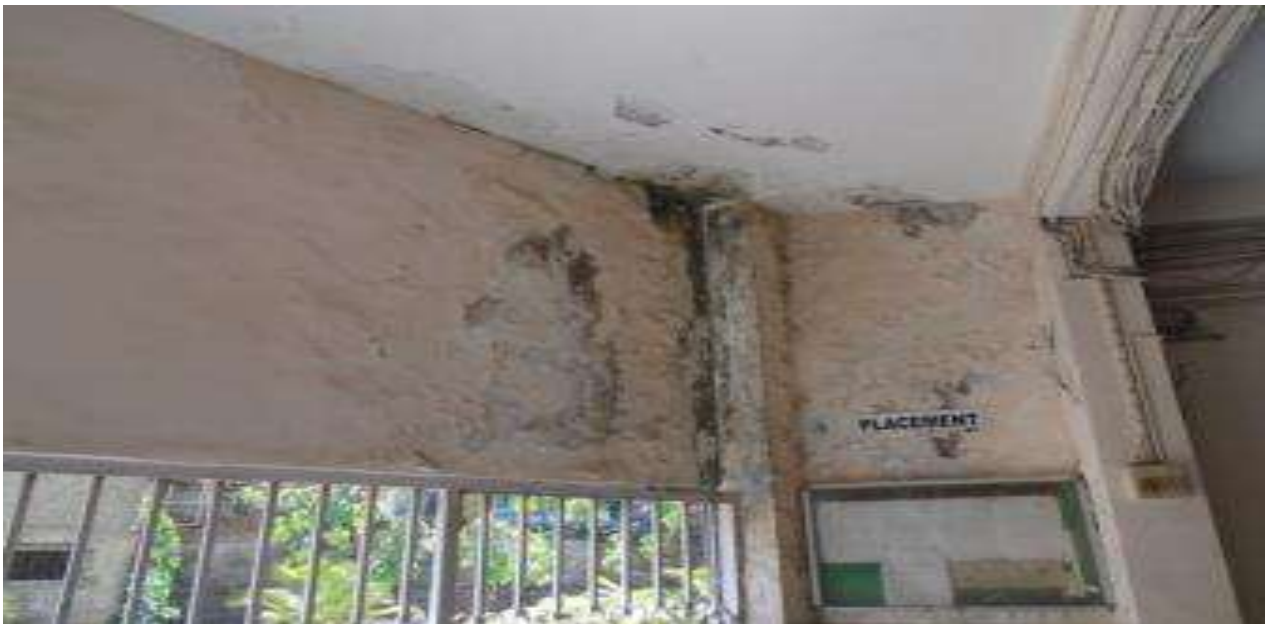
PH NO-28:-Photograph showing leakage mark on column and wall at passage.

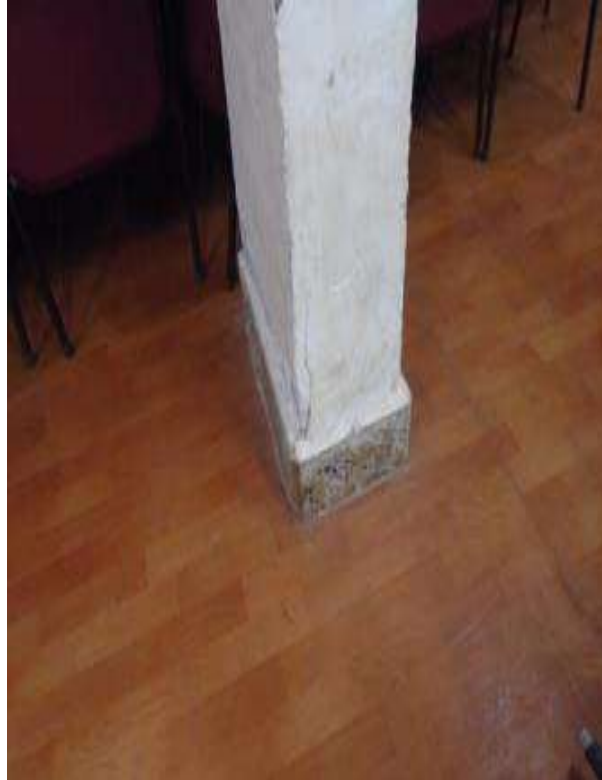
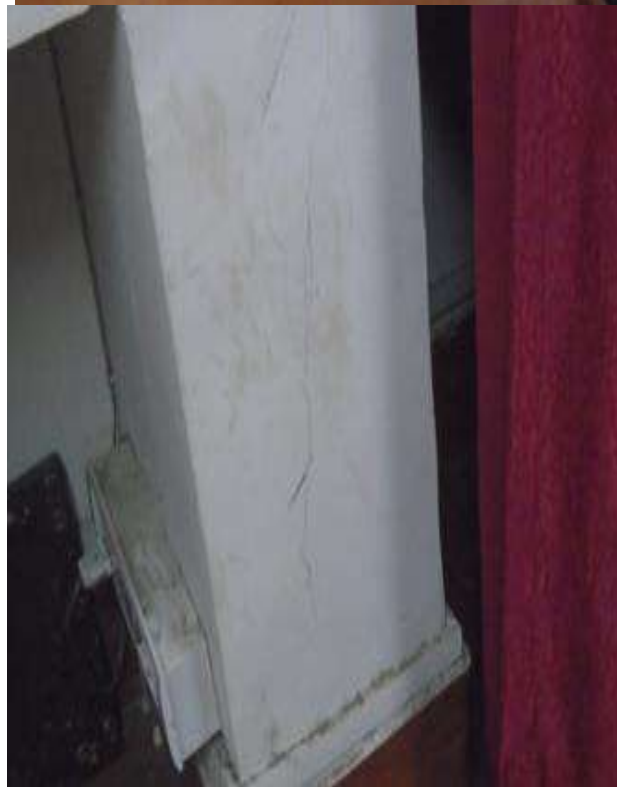
PH NO-29 & 30:-Photograph showing crack on column at various locations of auditorium.
