## SADHANA EDUCATION SOCIETY'S

(Registered under society's act of 1860 & Bombay Public Trust Act 1950)  
Linguistic (Gujarati) Minority

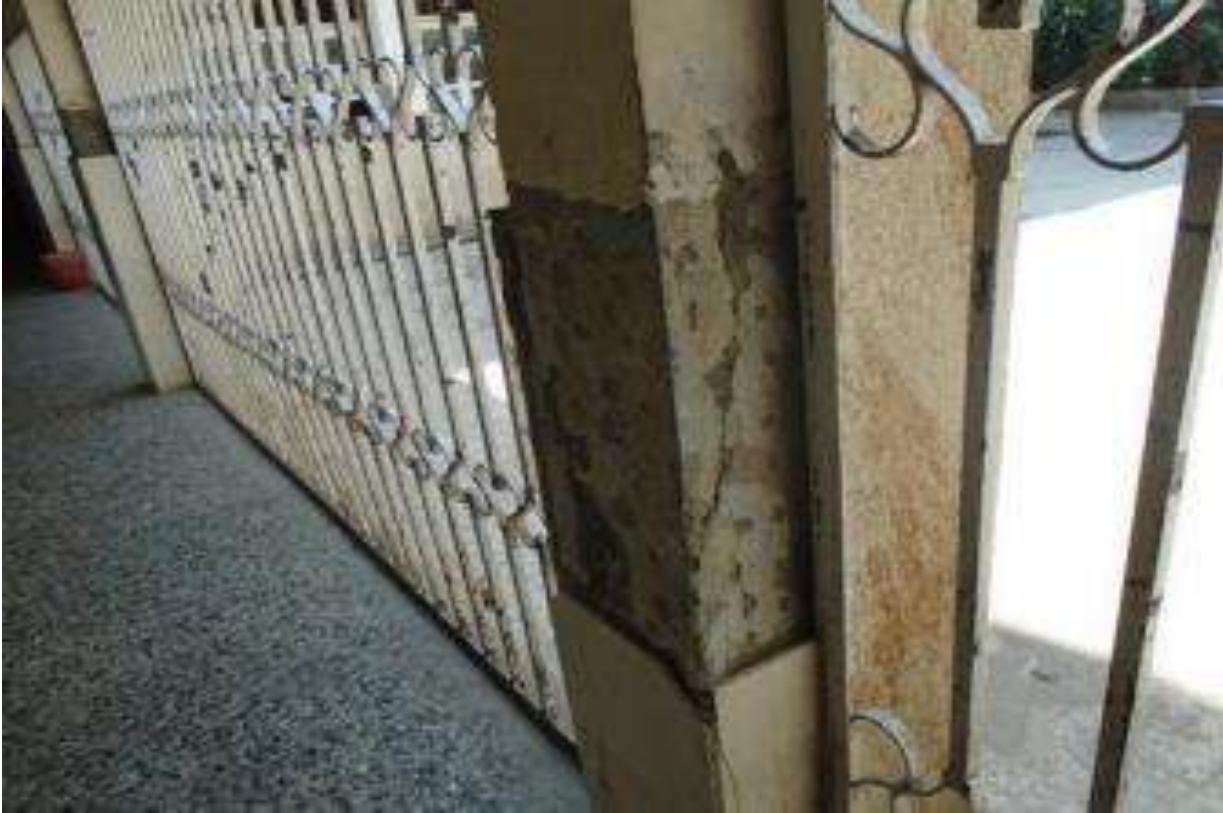
PH NO-31:-Photograph showing crack on column at passage.

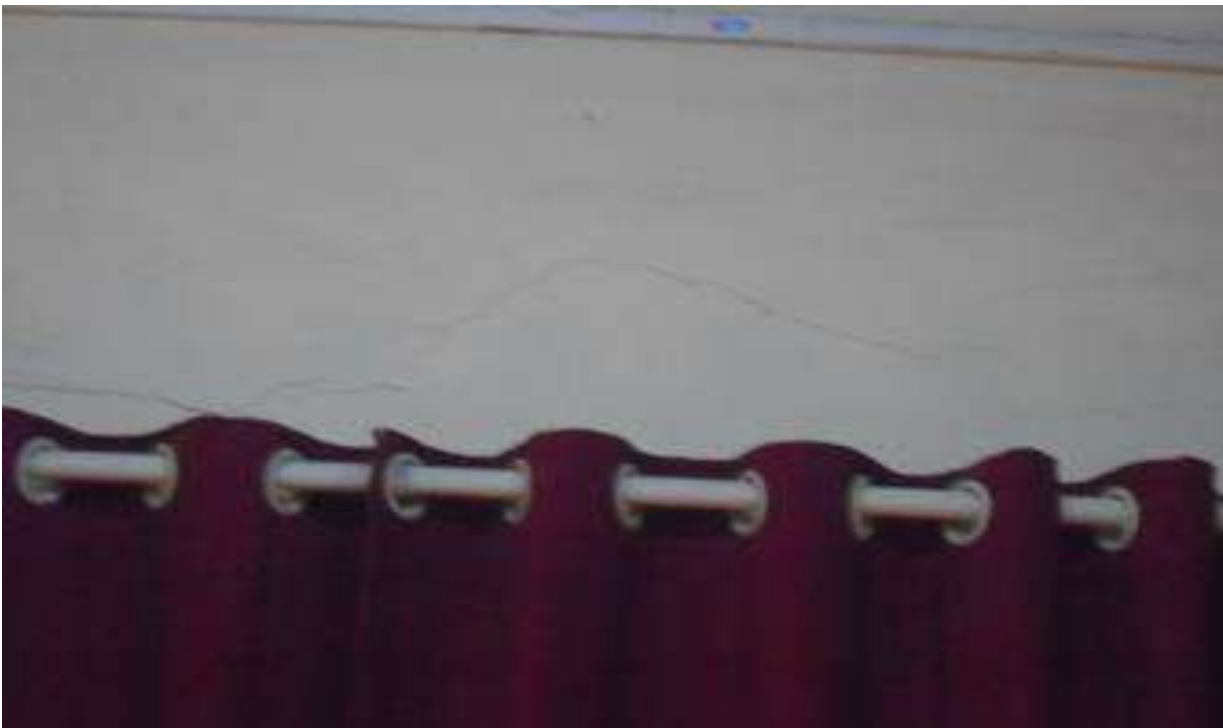
PH NO-32:-Photograph showing crack on beam at sports room.

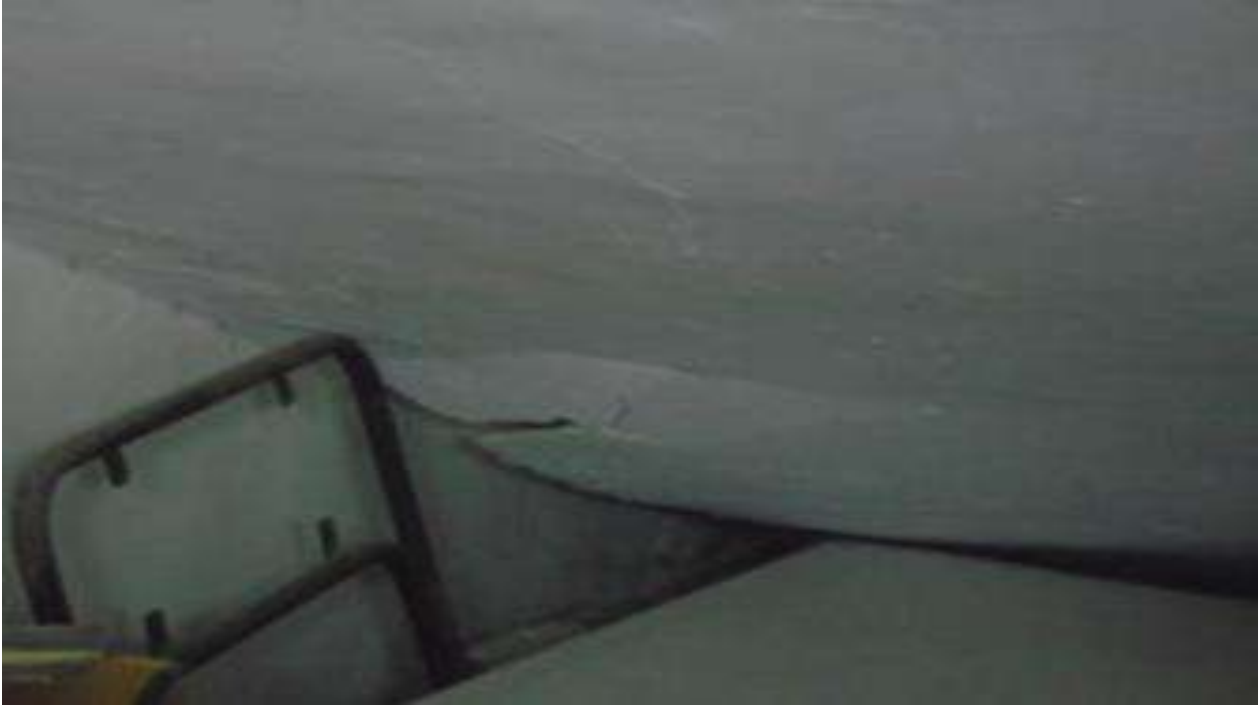
PH NO-33:-Photograph showing bulge of concrete cover on slab at store room.

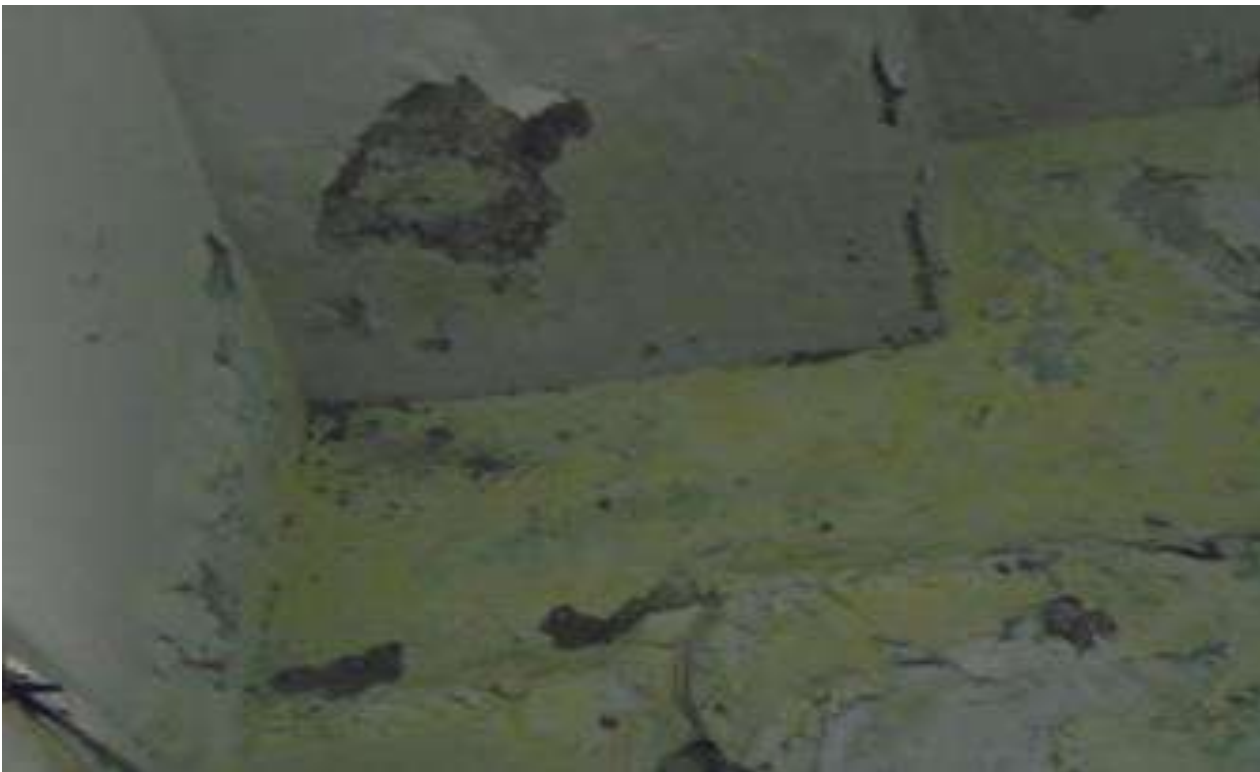
PH NO-34:-Photograph showing leakage mark and peeling of paint on sunken slab at gent's toilet.

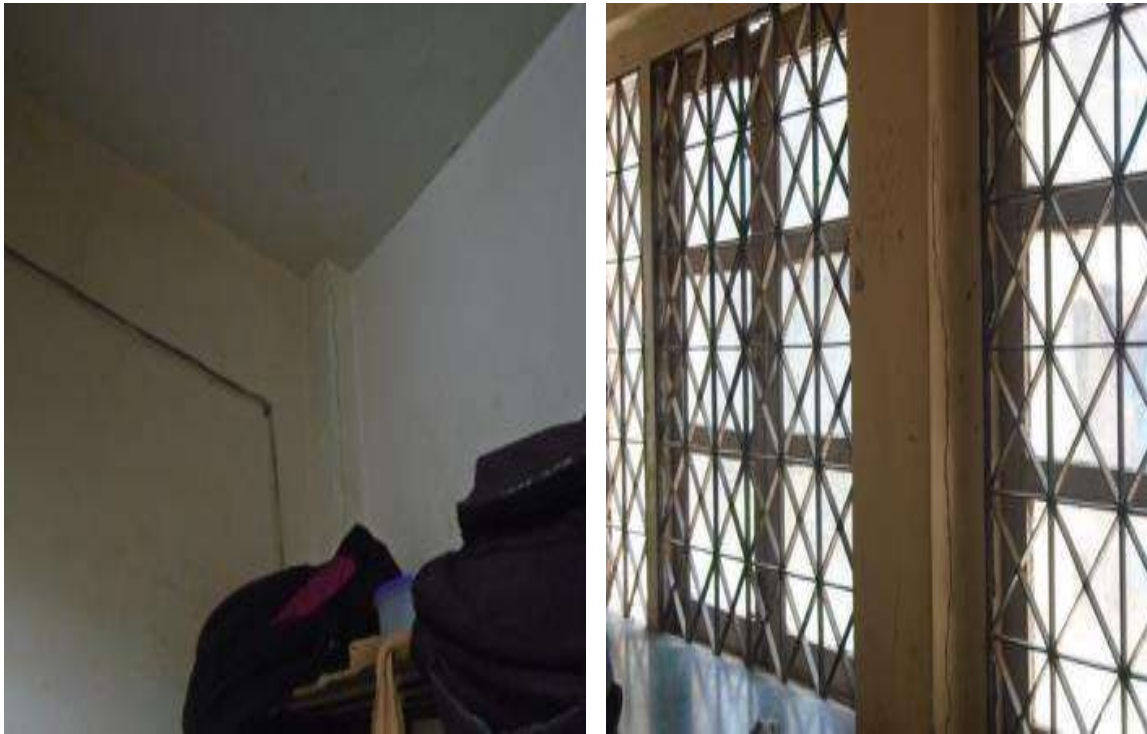
PH NO-35 & 36:-Photograph showing crack on column at various locations of canteen.

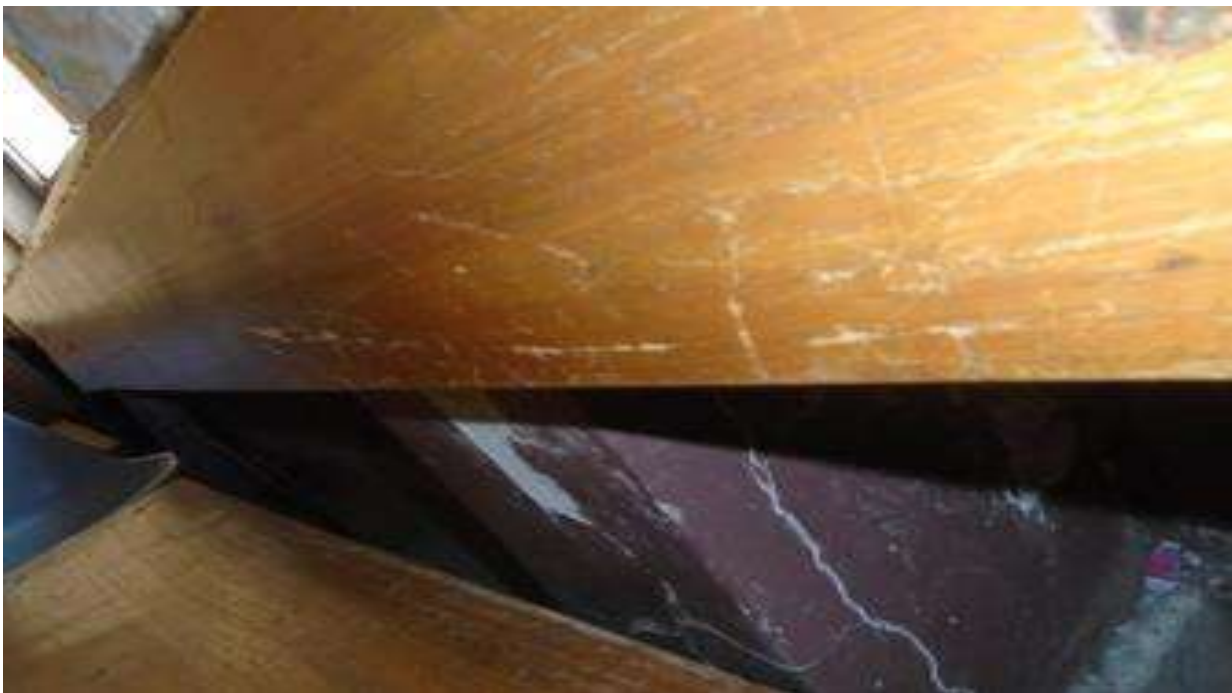
PH NO-37:-Photograph showing crack on column at various locations of room no-9.

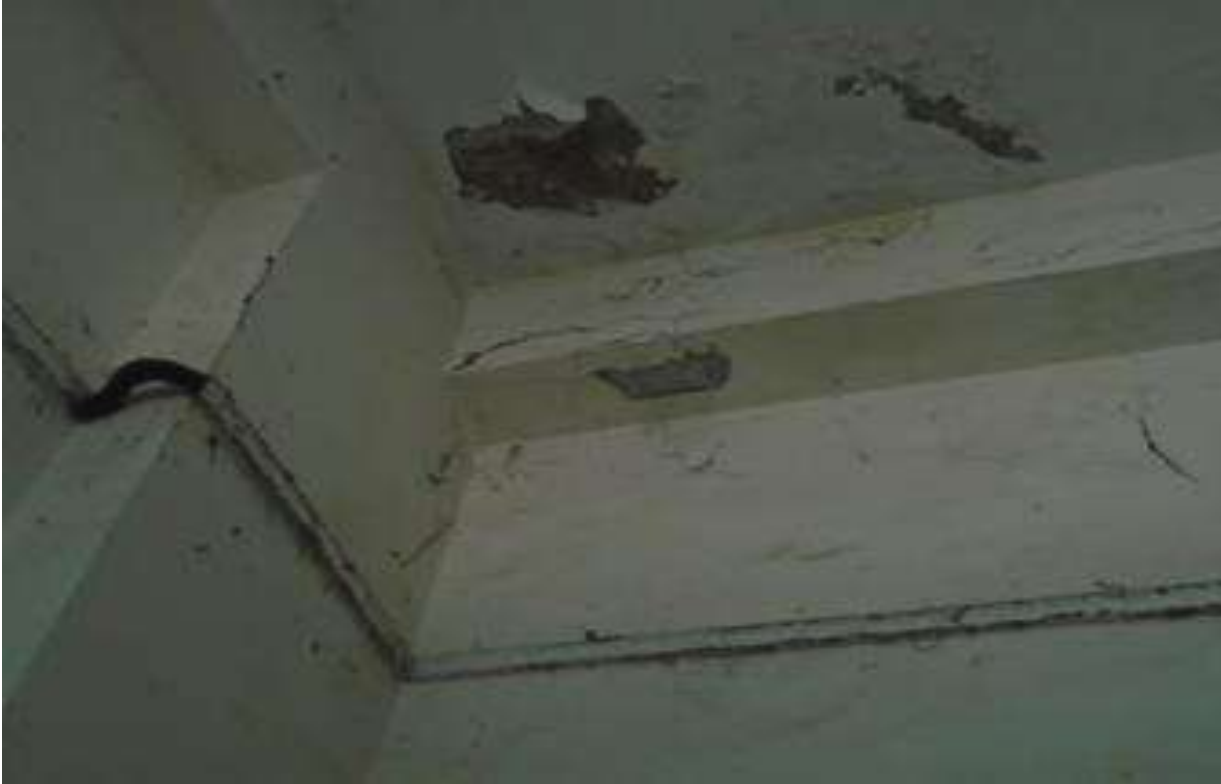
PH NO-38:-Photograph showing crack on beam at gents toilet.

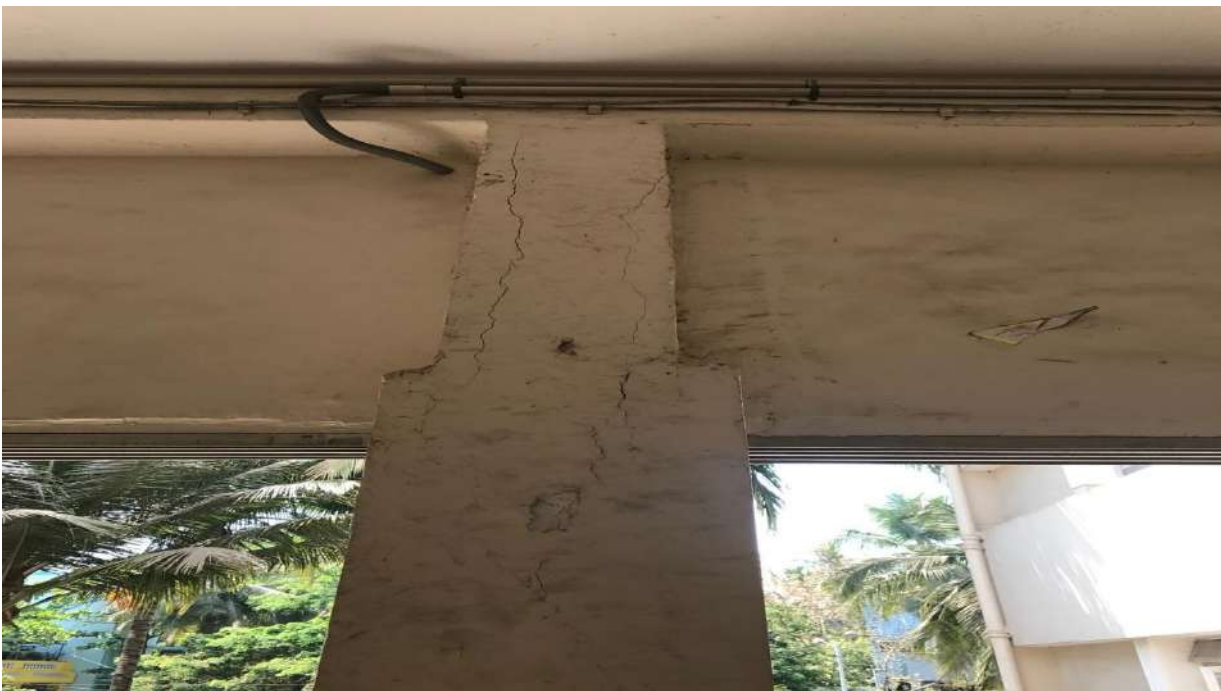
PH NO-39:-Photograph showing crack on column at some locations of passage.

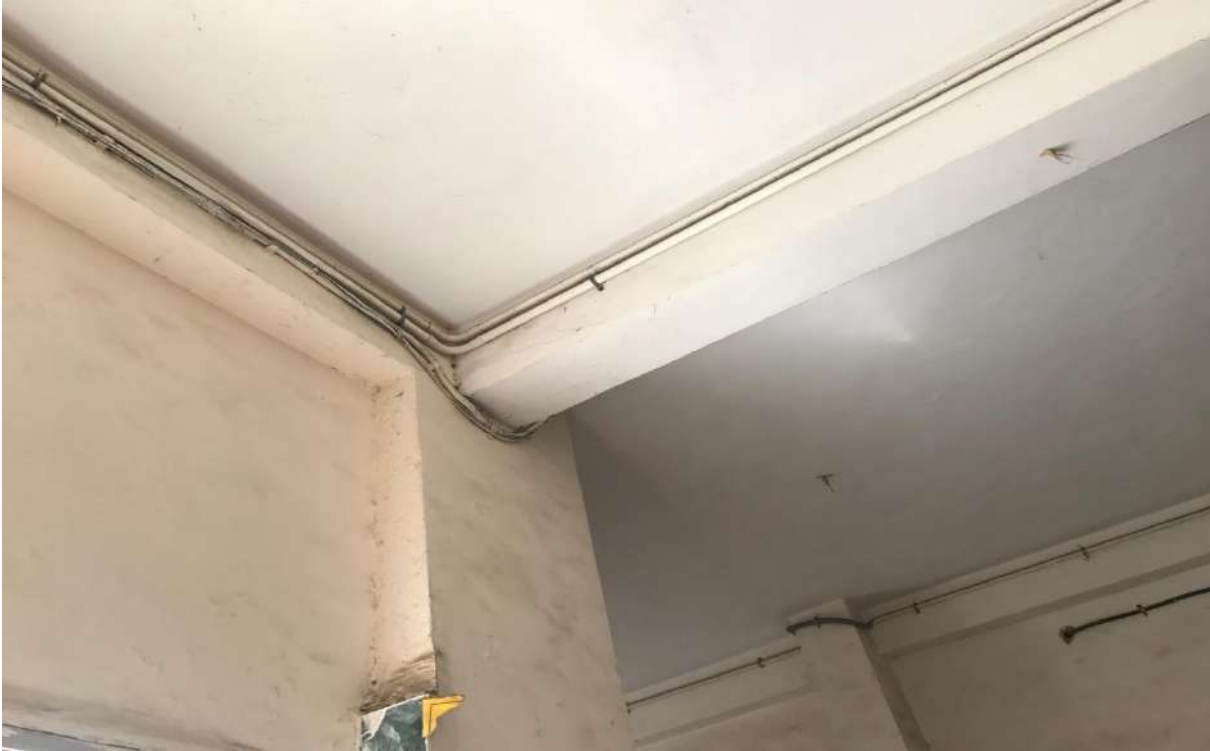
PH NO-40:-Photograph showing crack on beam at passage.

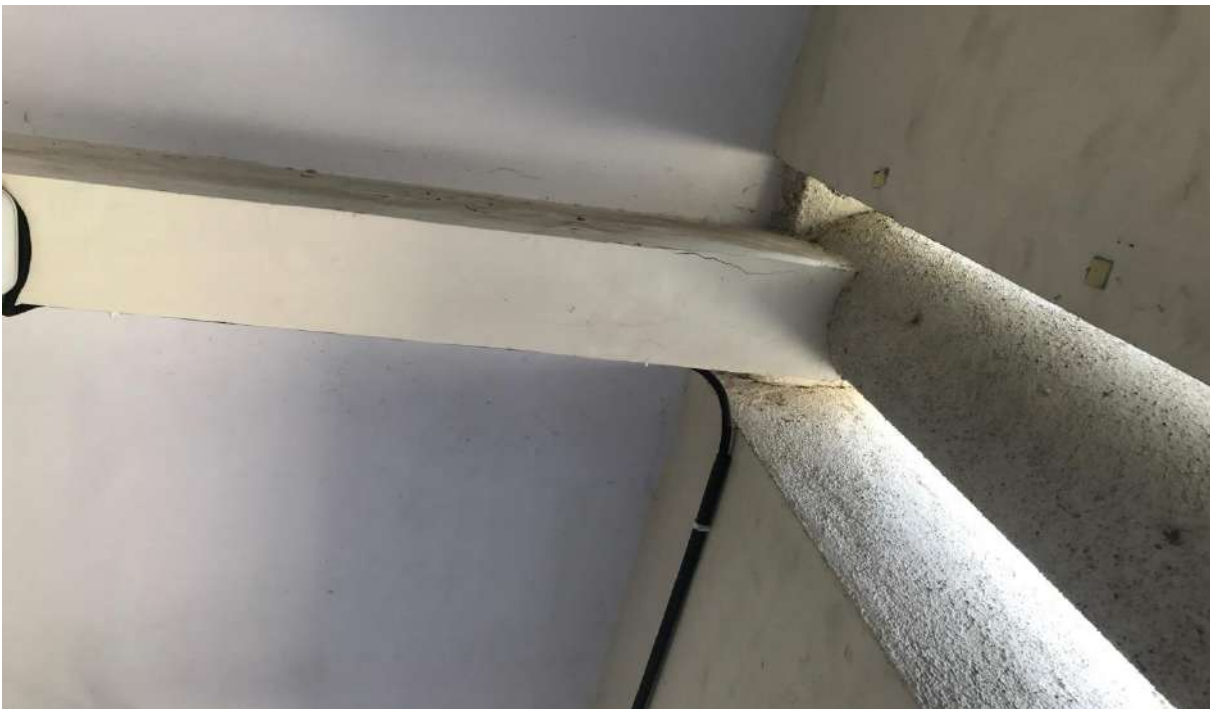
PH NO-41:-Photograph showing crack on beam at various locations of passage.

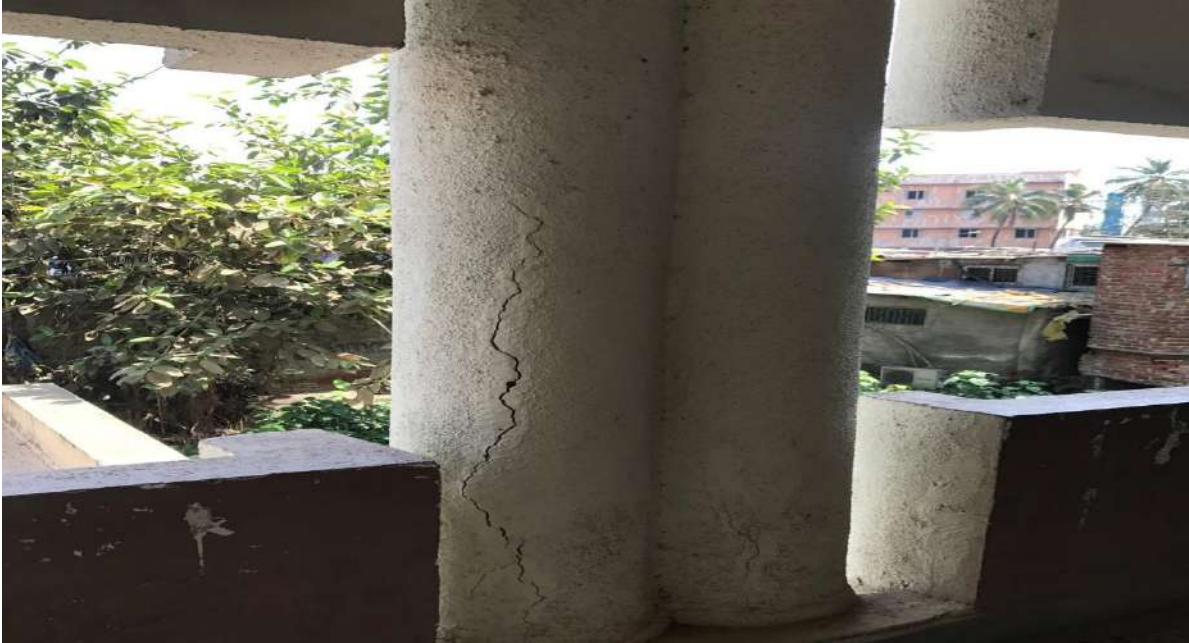
PH NO-42:-Photograph showing crack on column at various locations of passage.

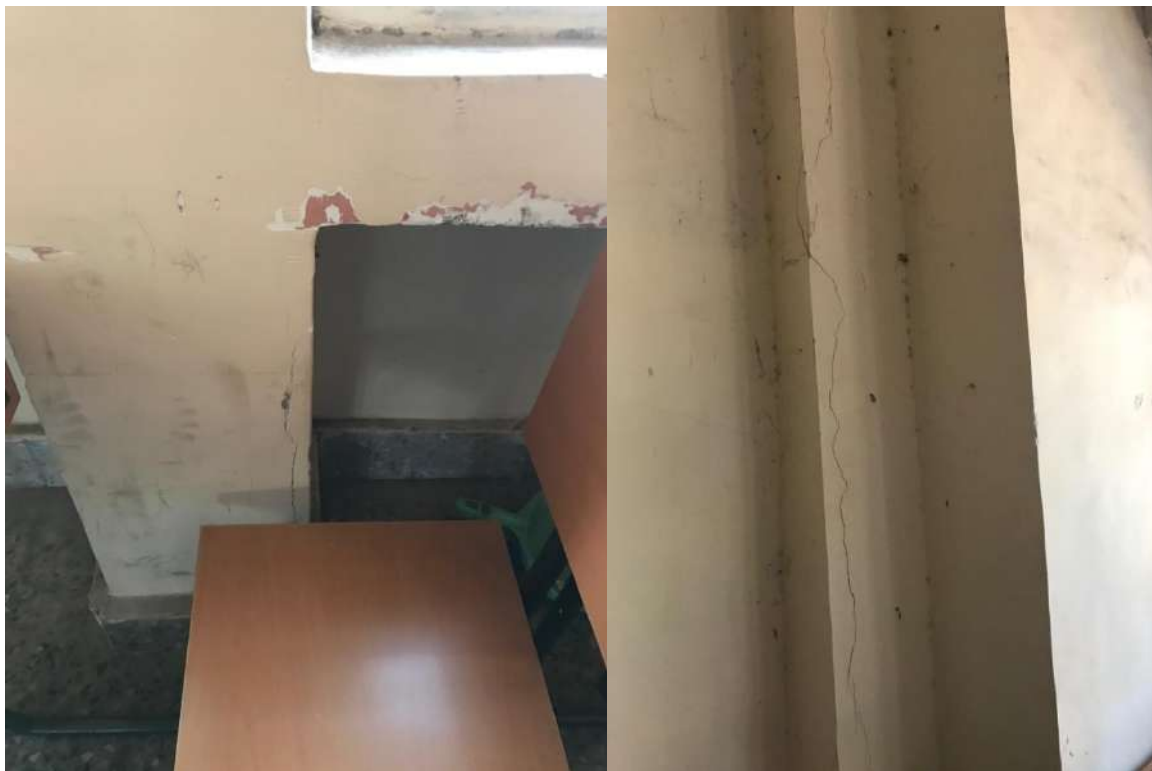
PH NO-43 & 44:-Photograph showing crack on column at various locations of room no-21.

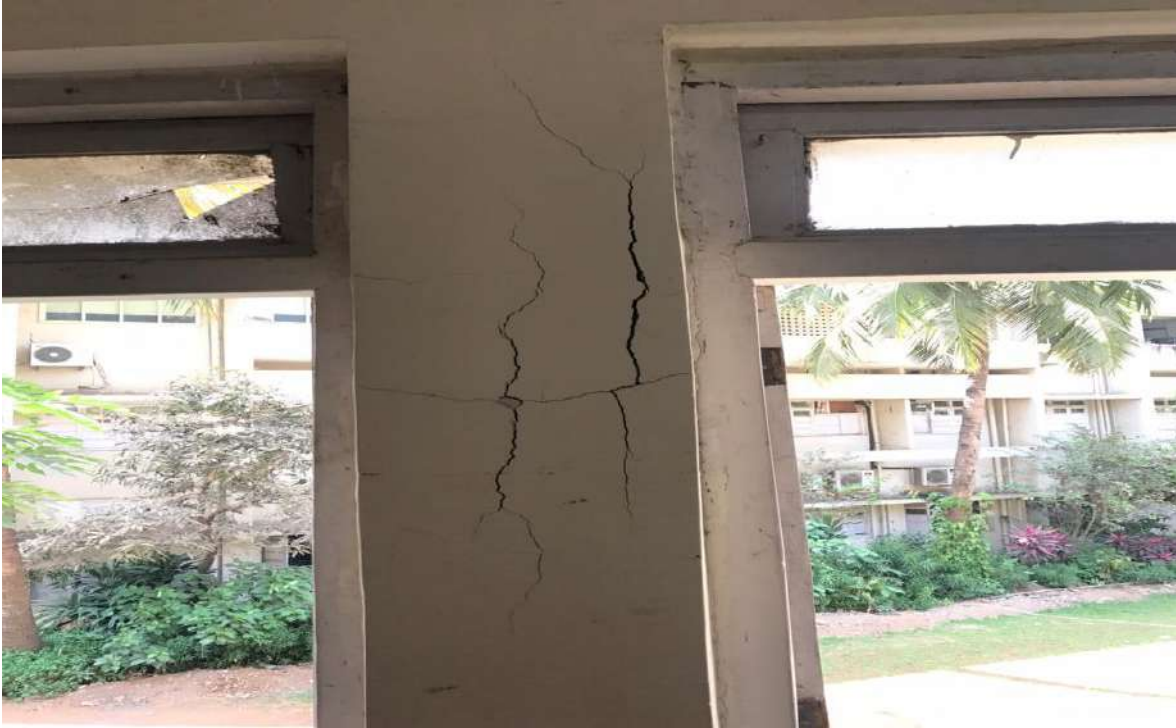
PH NO-45:-Photograph showing structural crack on column at various locations of room no-17.

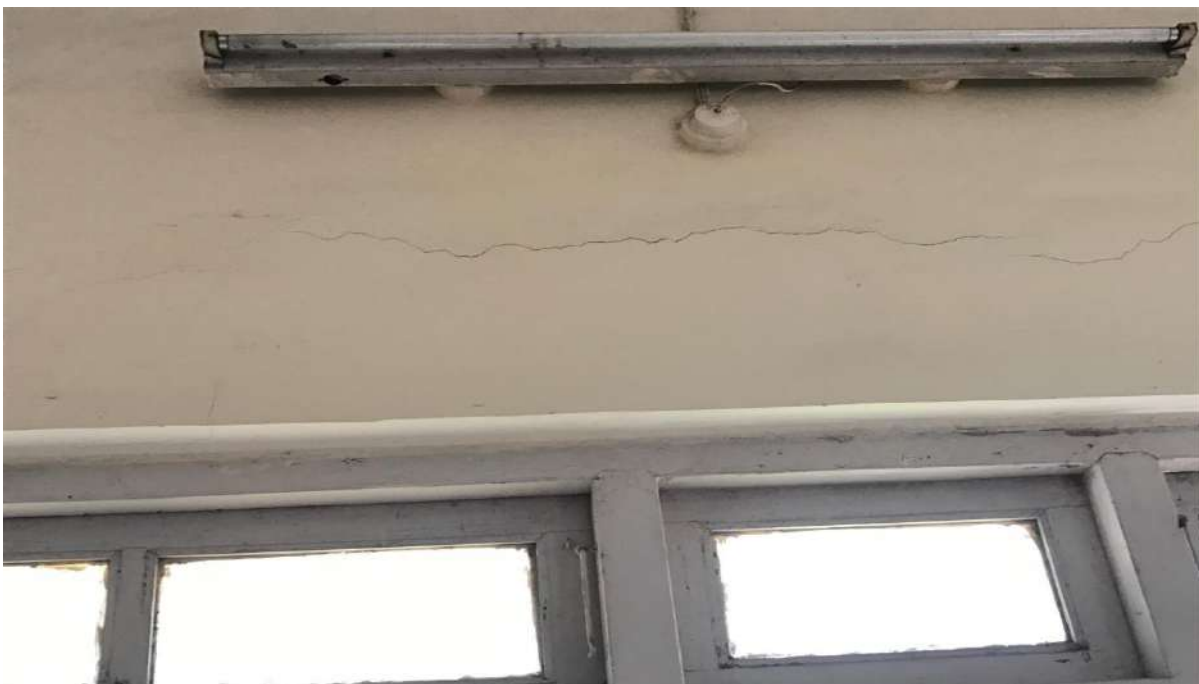
PH NO-46:-Photograph showing structural crack on lintel beam above window room no-17.

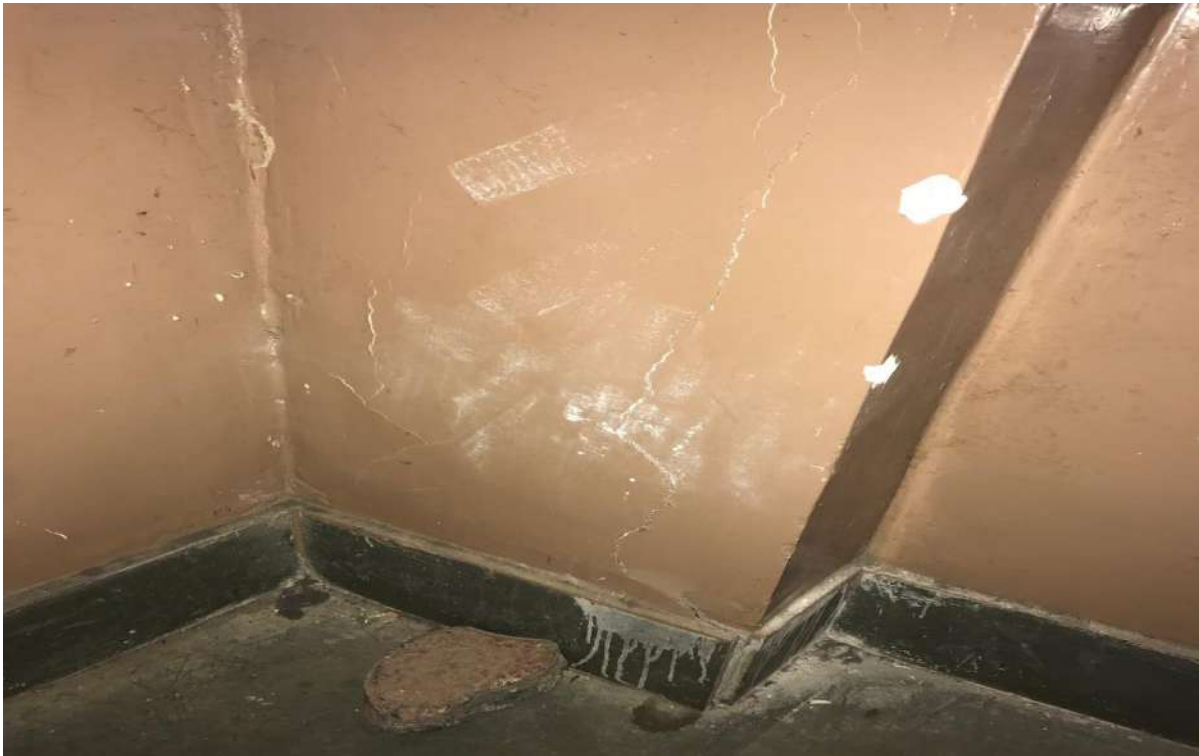
PH NO-47:-Photograph showing structural crack on column room no-16.

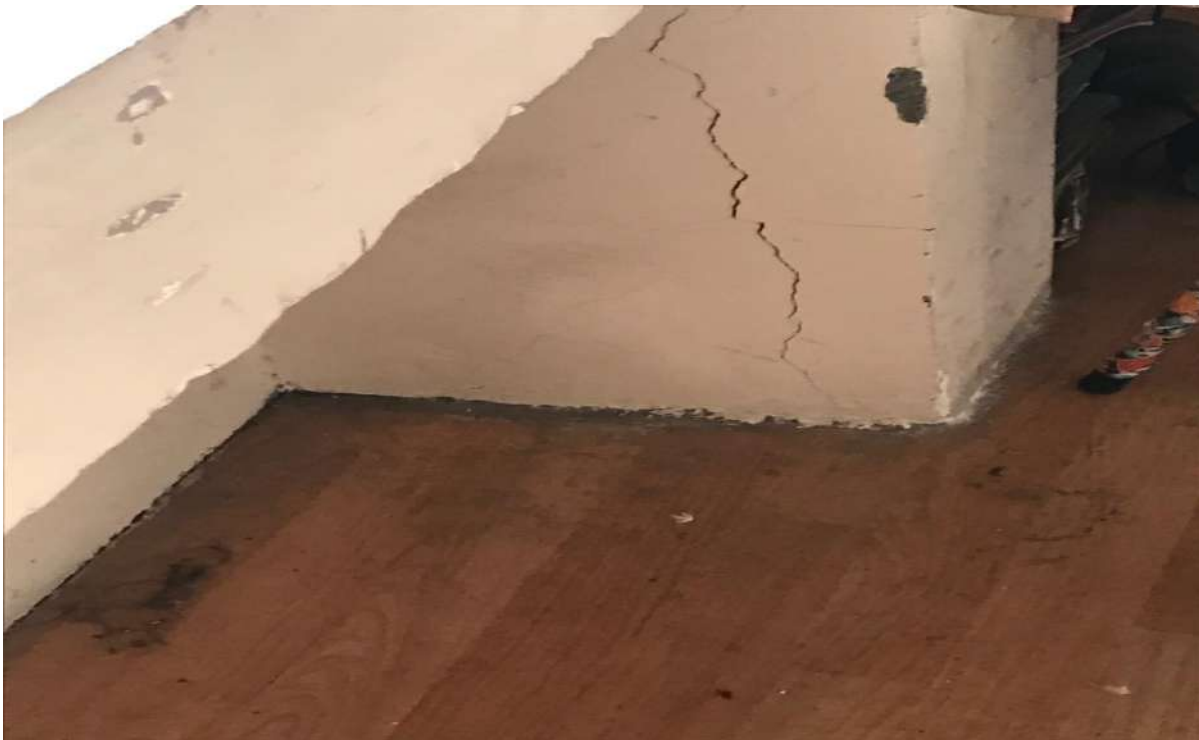
PH NO-48:-Photograph showing structural crack on column room no-14.

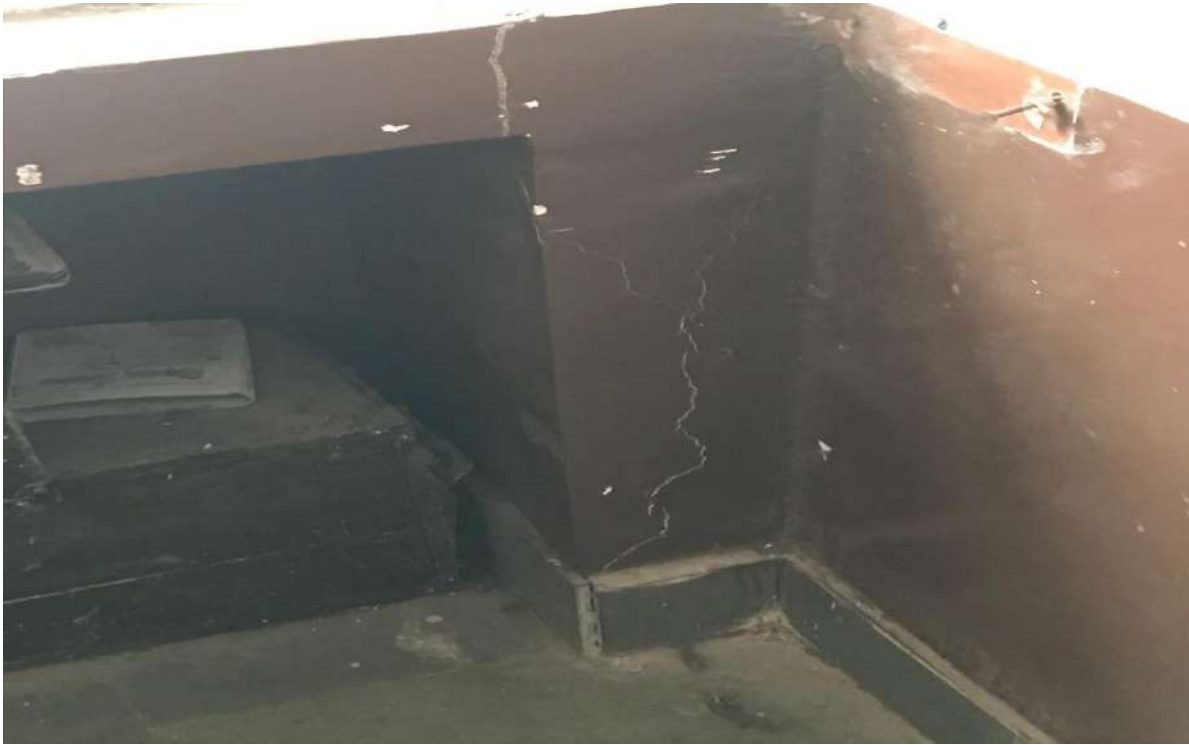
PH NO-49:-Photograph showing structural crack on column room no-15.

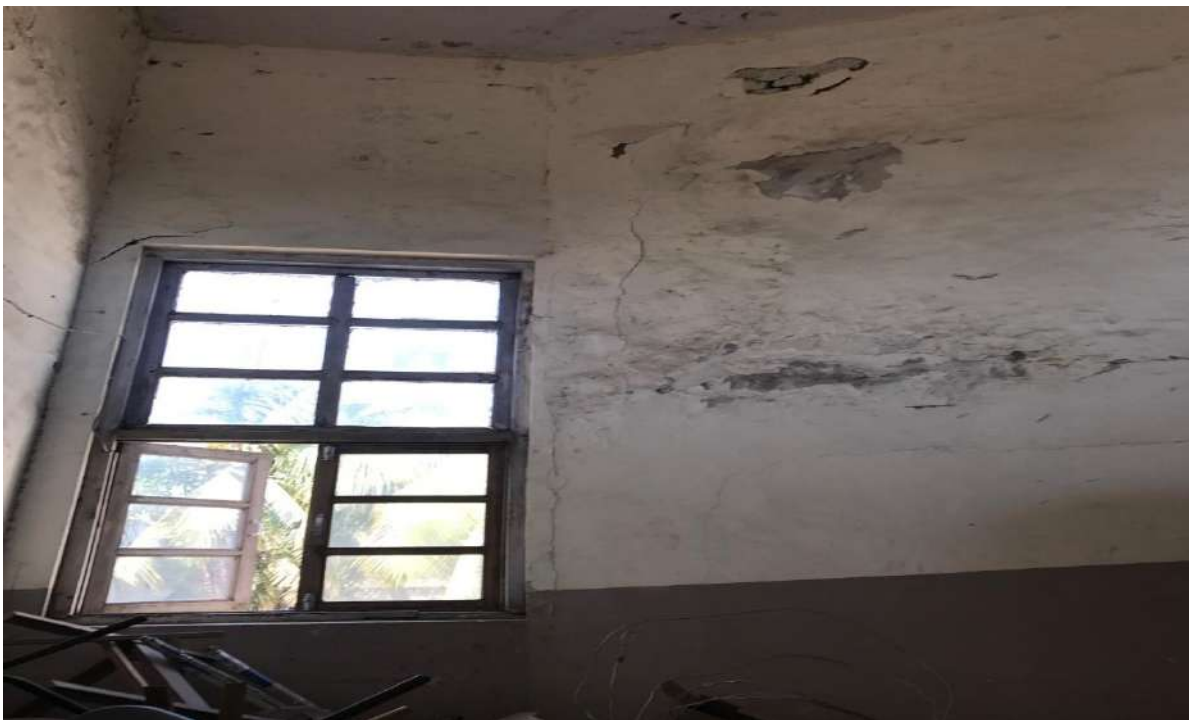
PH NO-50:-Photograph showing structural crack on column at second floor staircase area.

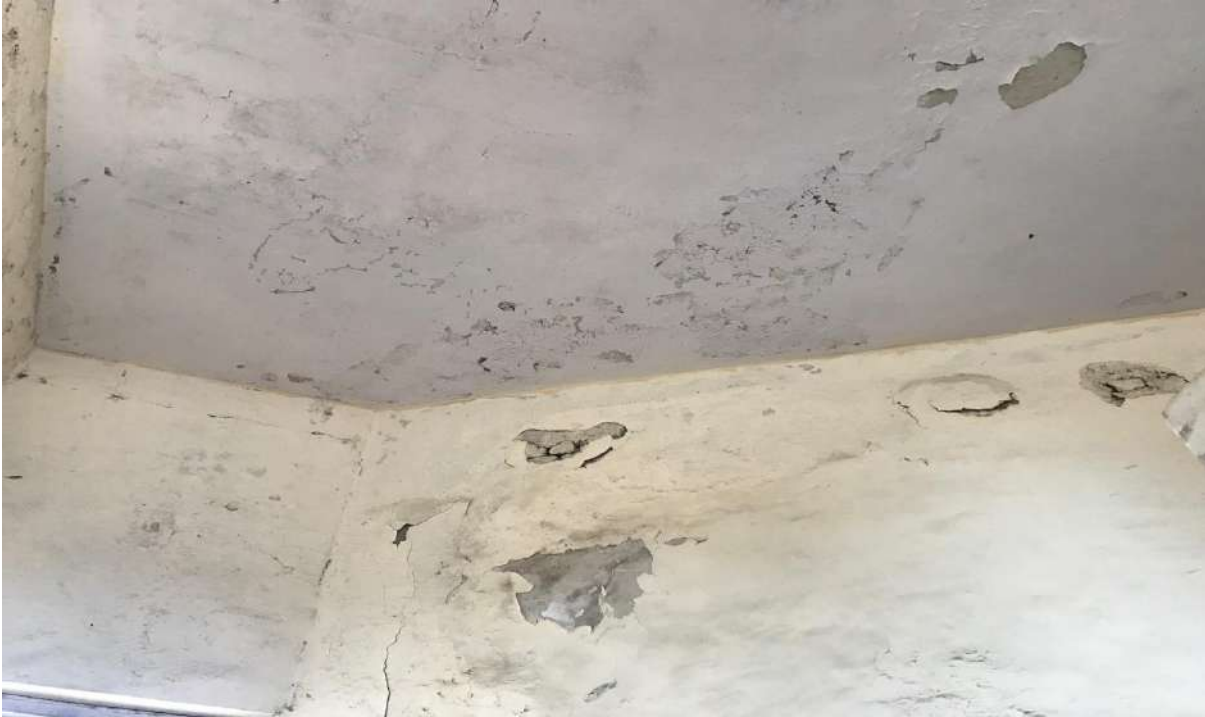
PH NO-51:-Photograph showing de bonded concrete cover on beam at second floor staircase area.

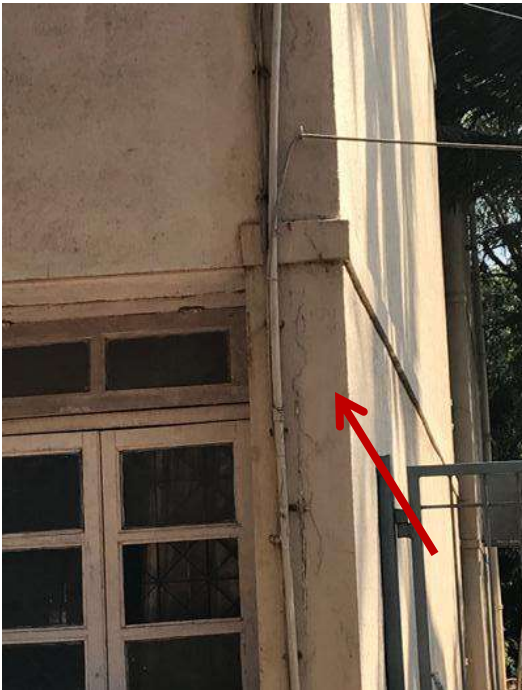
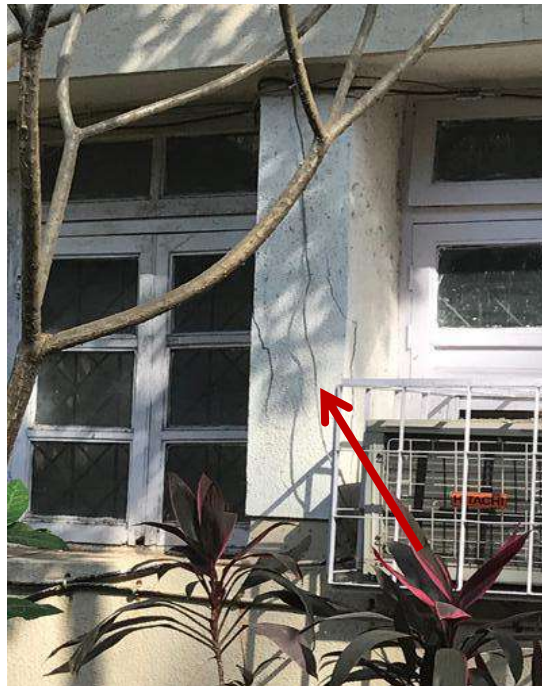
PH NO-02 & 03:-Photograph showing crack on column at various locations of existing structure.

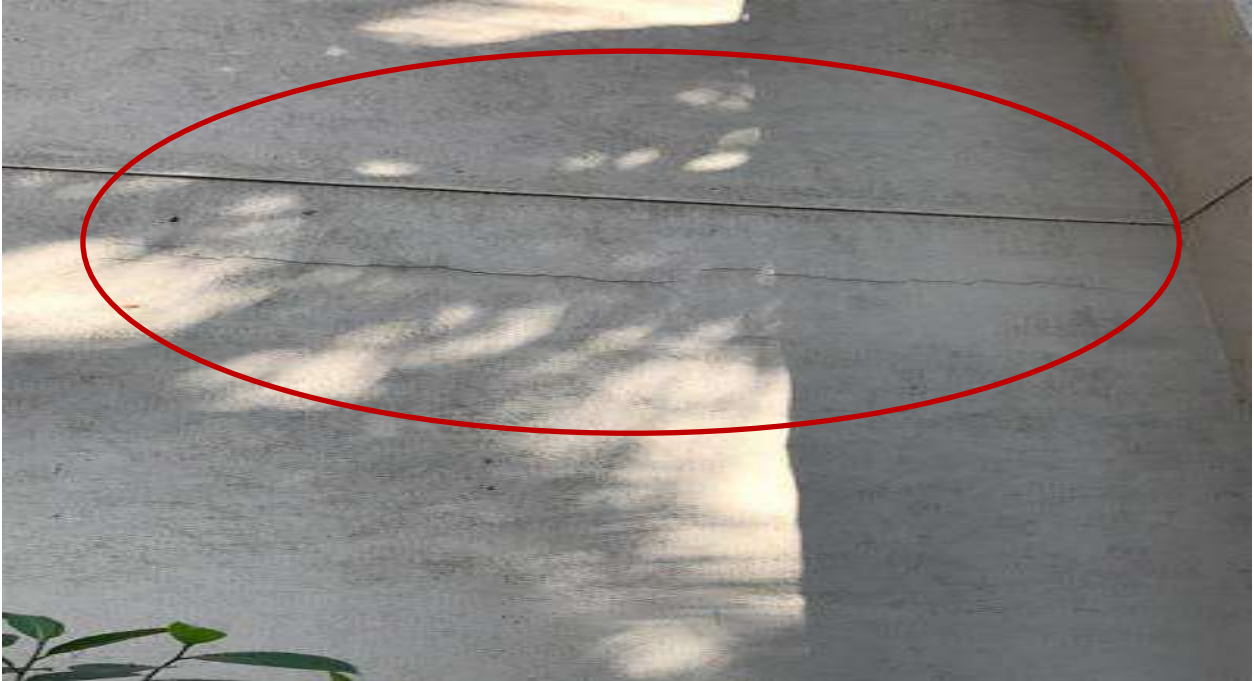
PH NO-04:-Photograph showing separation crack between beam and wall.

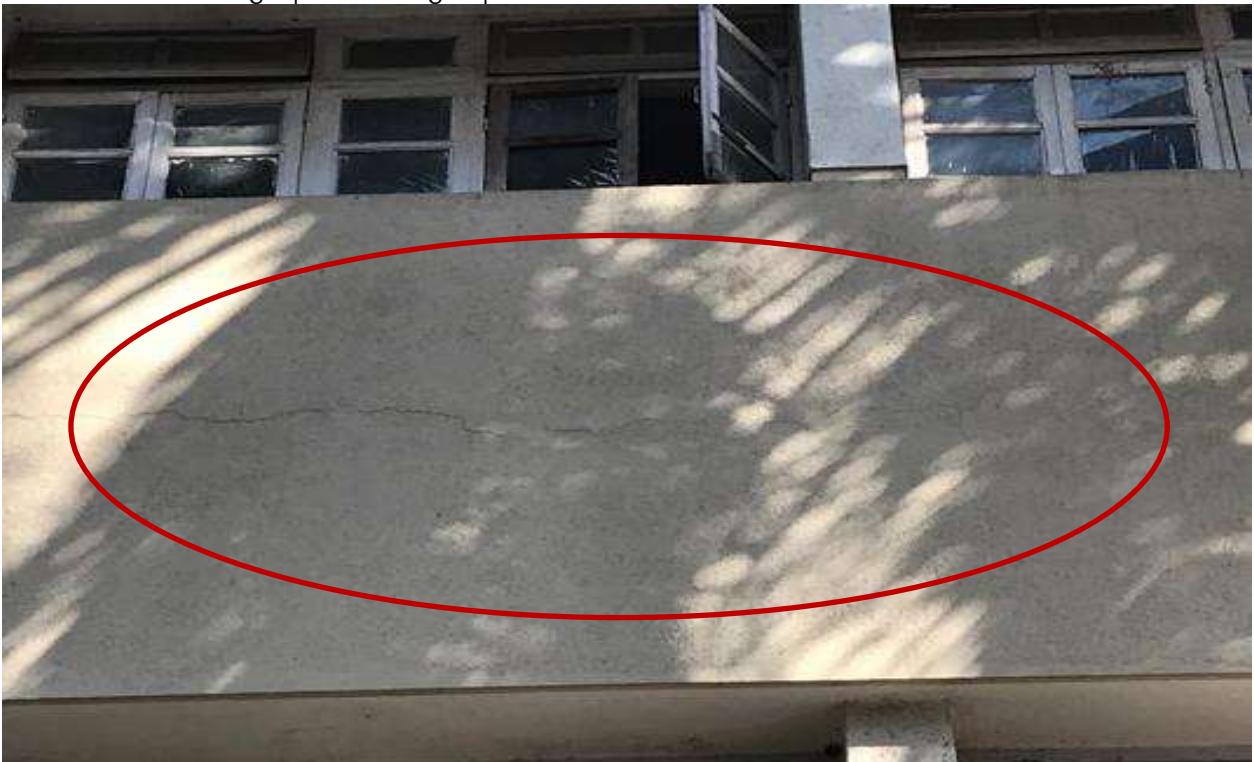
PH NO-05:-Photograph showing crack on RCC pardi at various locations.

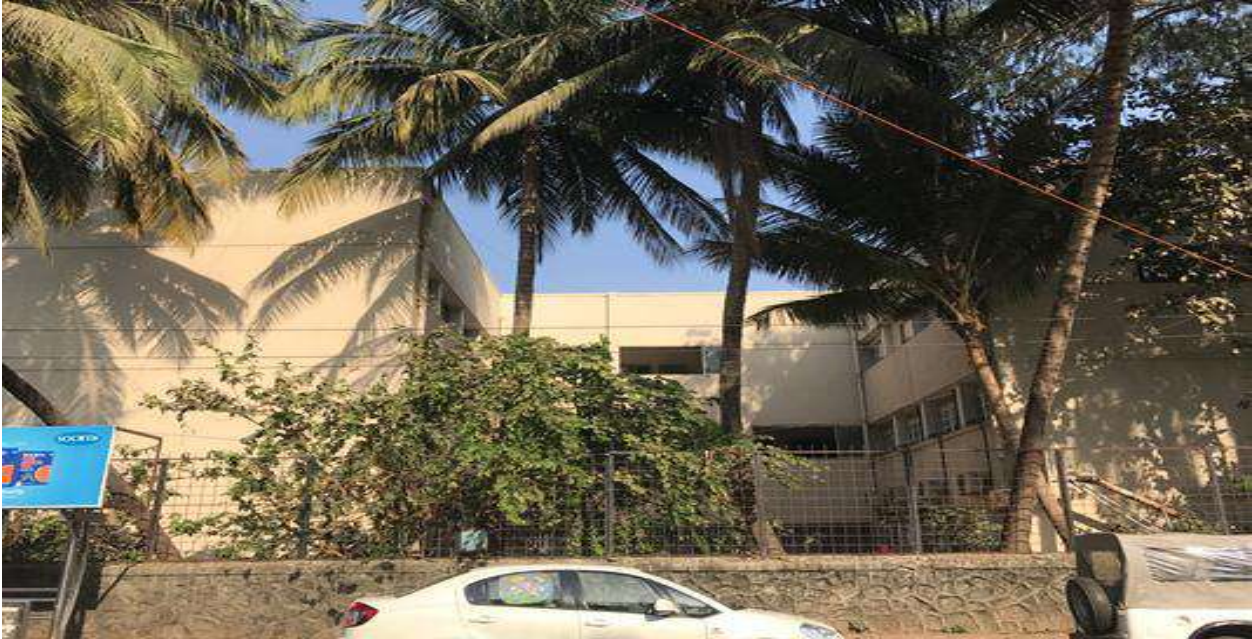
PH NO-06:-Photograph showing the existing view of structure.

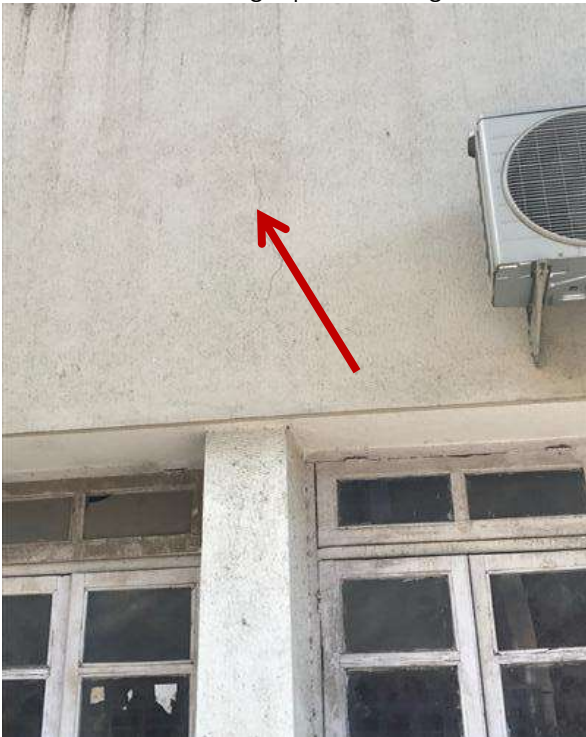
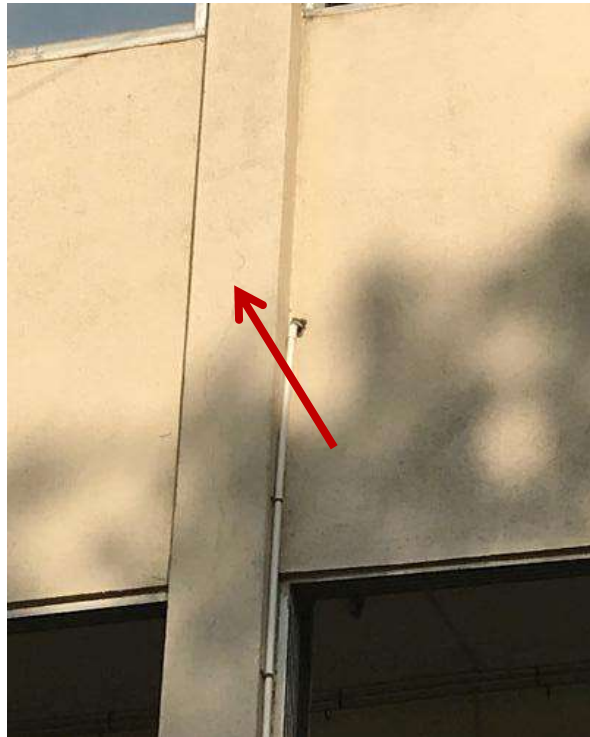
PH NO-07 & 08:-Photograph showing crack on column at various locations of existing structure.

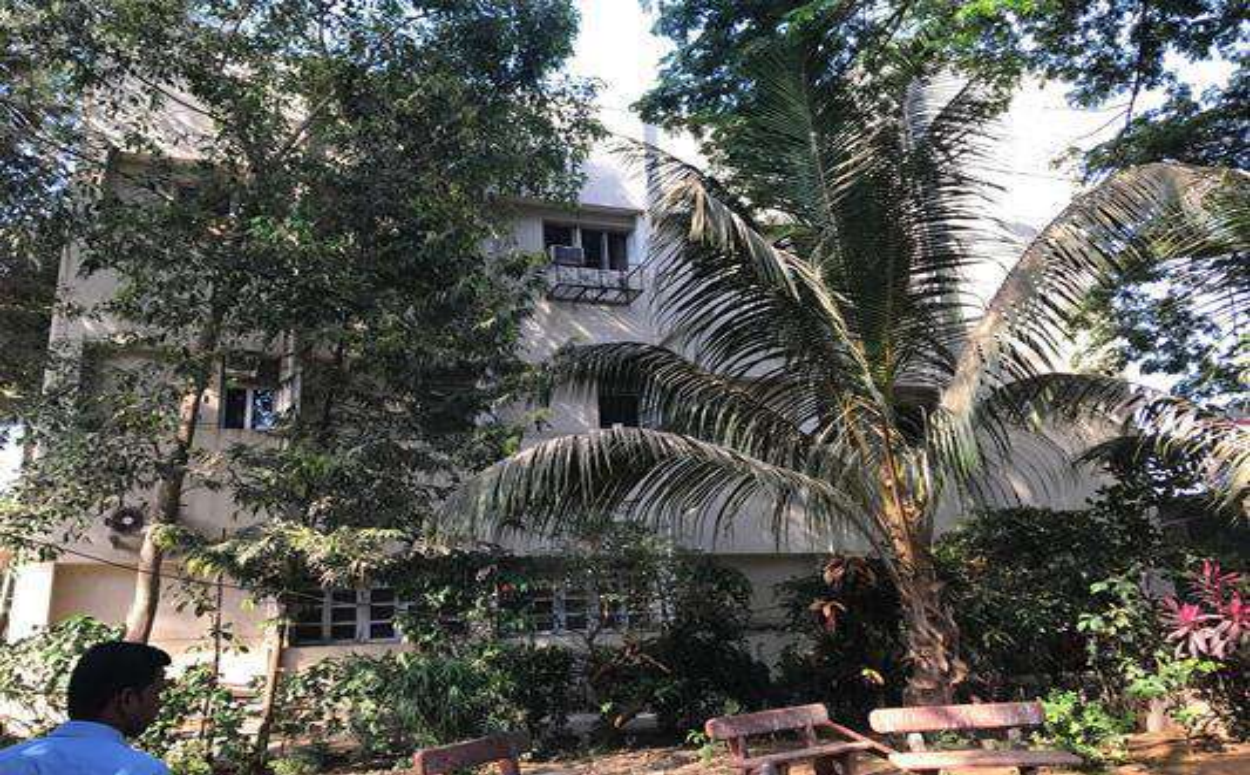
PH NO-09:-Photograph showing the existing view of structure.

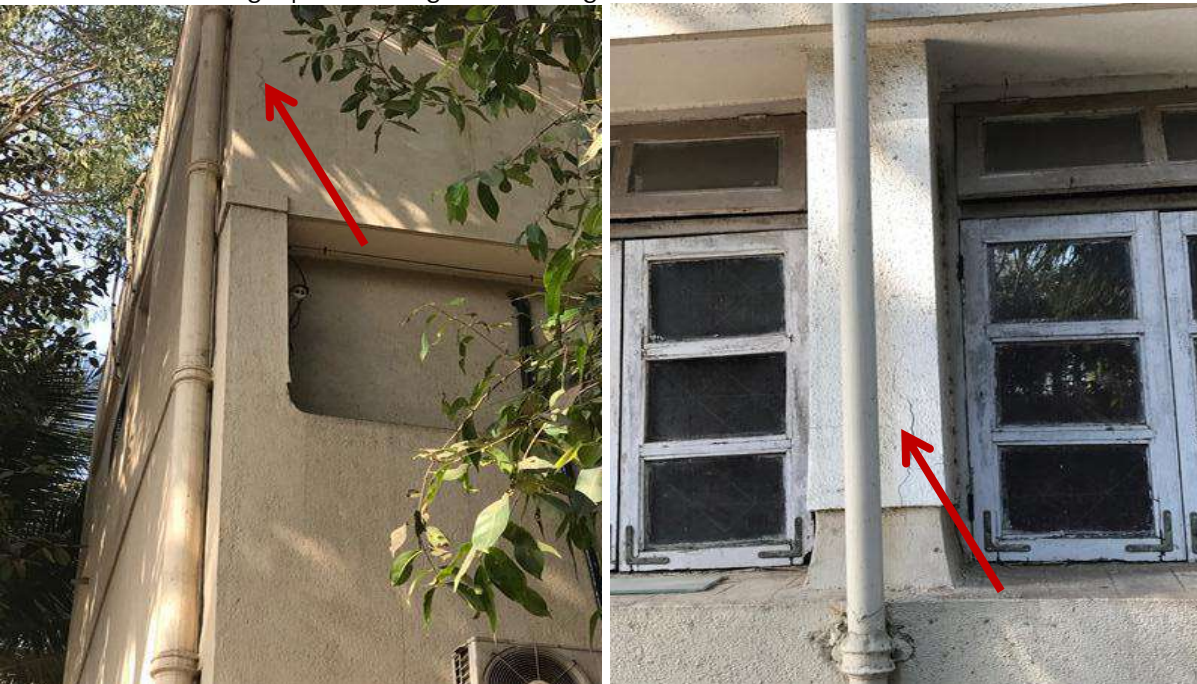
PH NO-10:-Photograph showing crack on column at various locations of existing structure.
