## SADHANA EDUCATION SOCIETY'S

(Registered under society's act of 1860 & Bombay Public Trust Act 1950)  
Linguistic (Gujarati) Minority

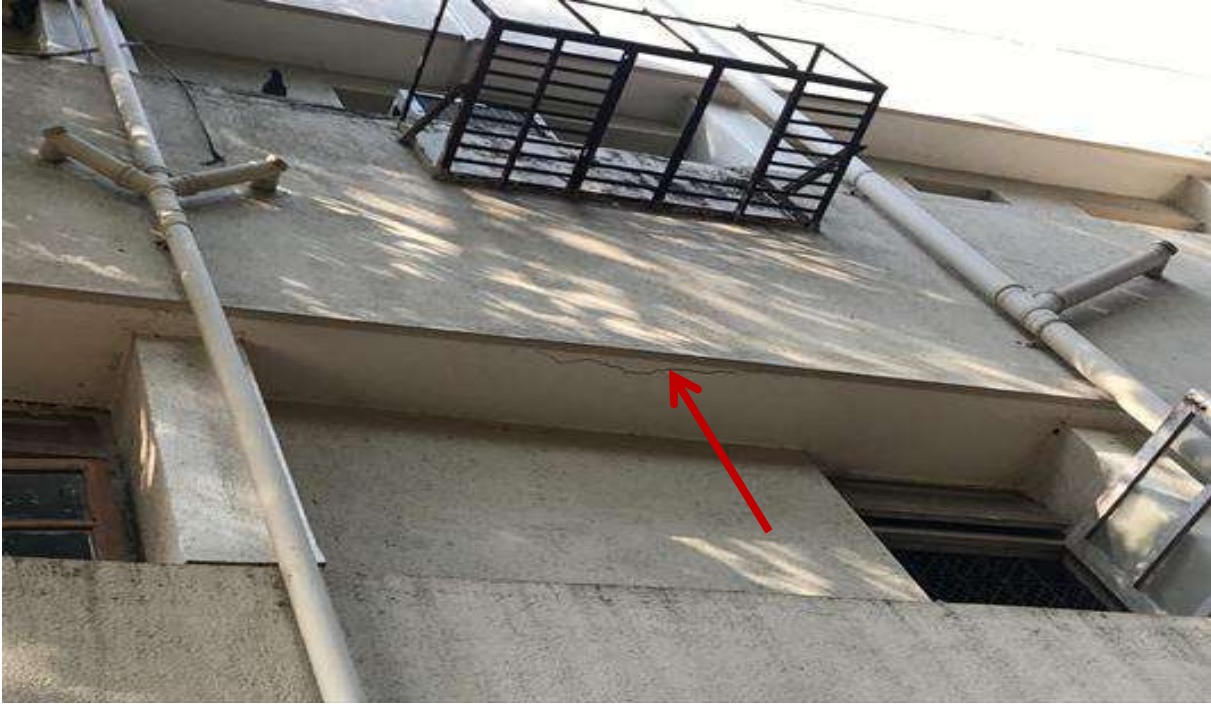
PH NO-11:-Photograph showing crack on beam.  
EAST

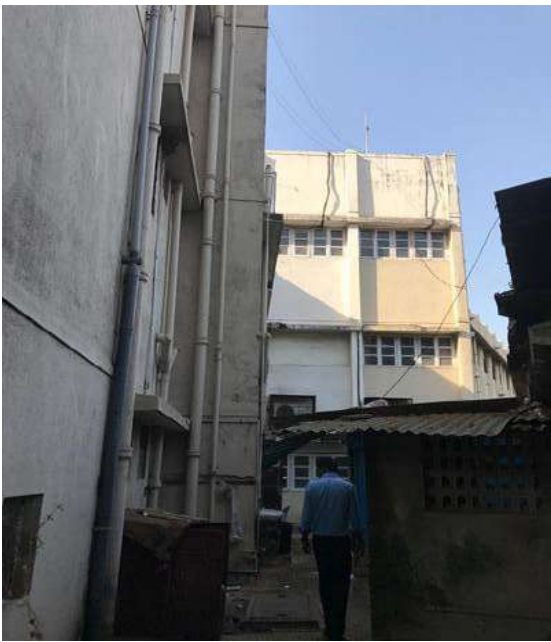
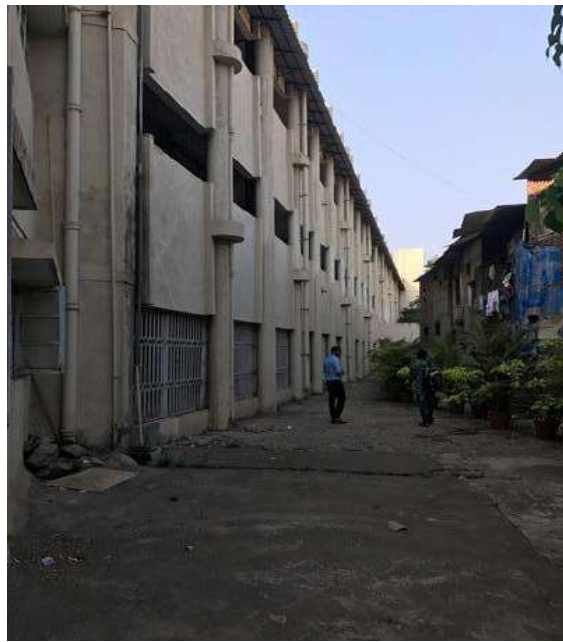
PH NO-12 & 13:-Photograph showing the existing view of structure.

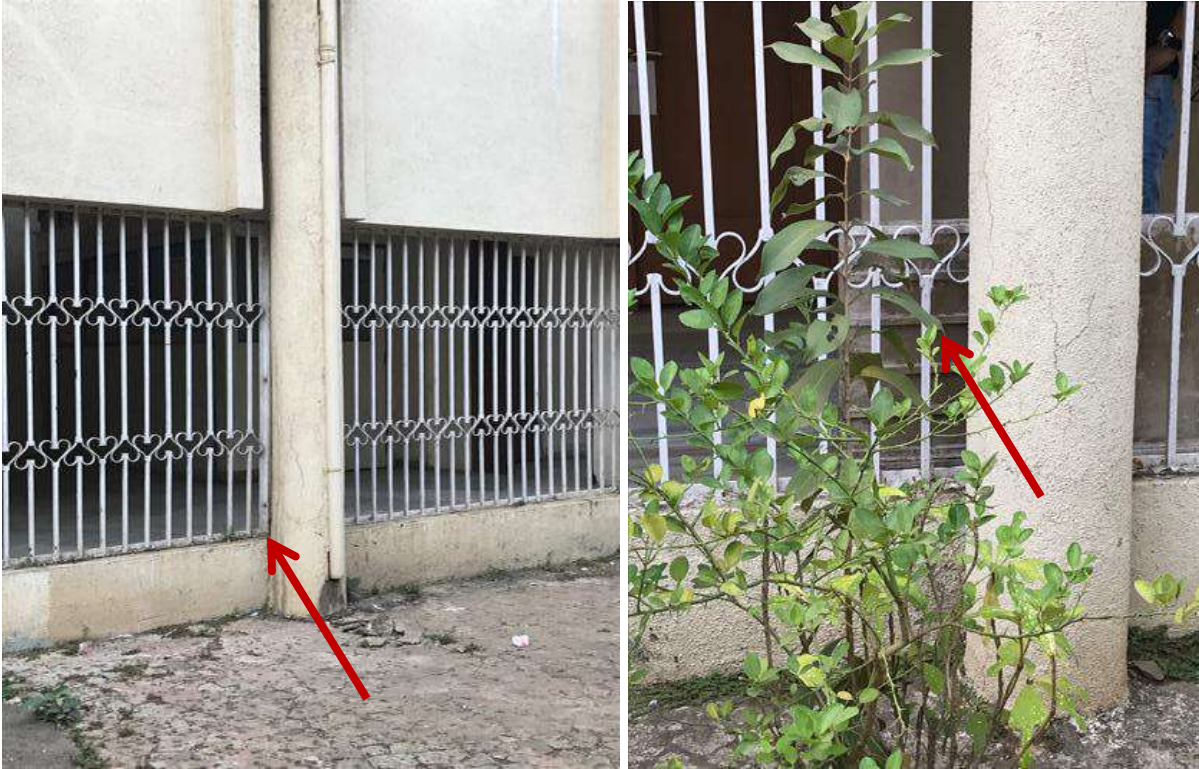
PH NO-14 & 15:-Photograph showing crack on circular column at various locations of existing structure.

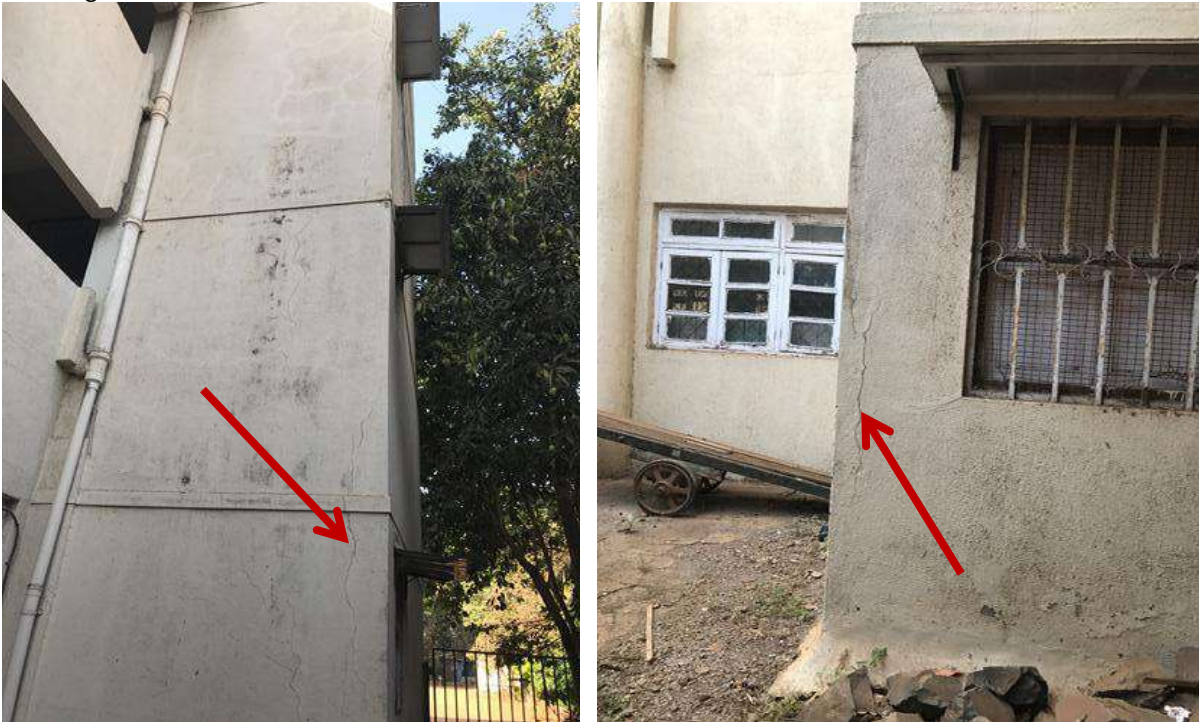
PH NO-16 & 17:-Photograph showing crack on column at various locations of existing structure

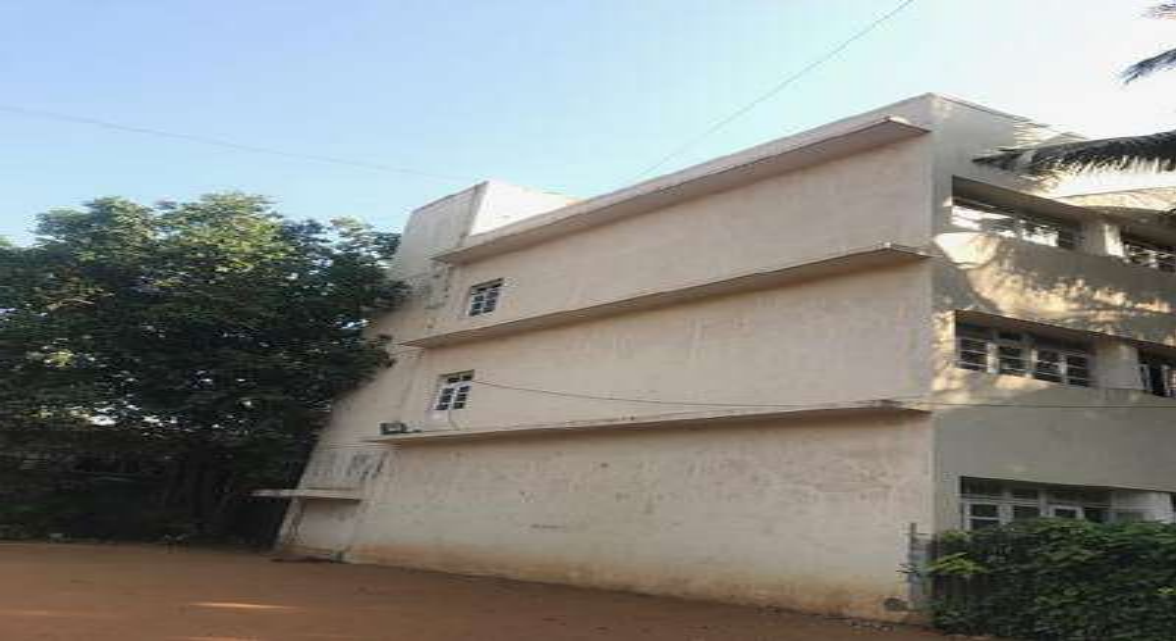
PH NO-18:-Photograph showing the existing view of structure.

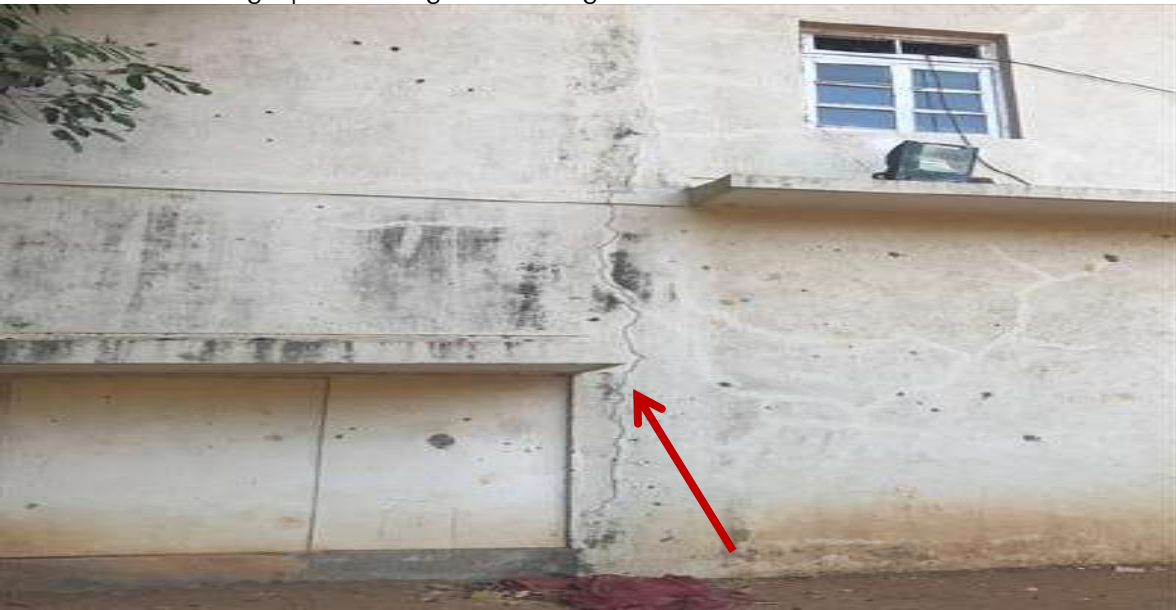
PH NO-19:-Photograph showing structural crack on column and surface crack on external wall in patches.

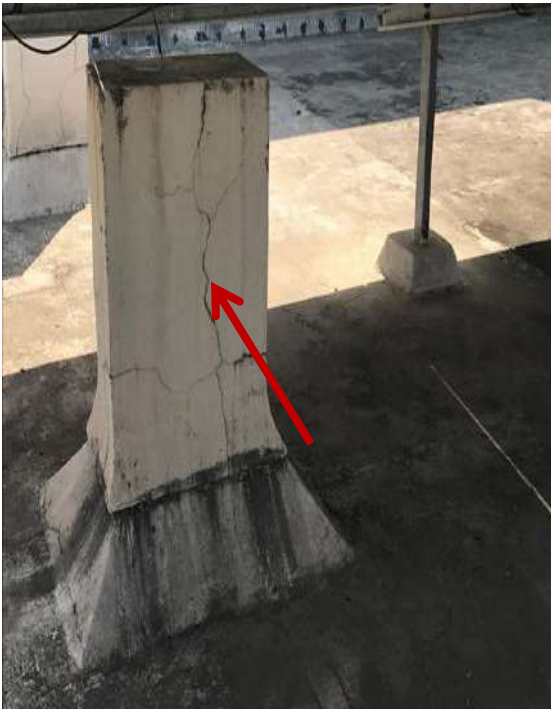
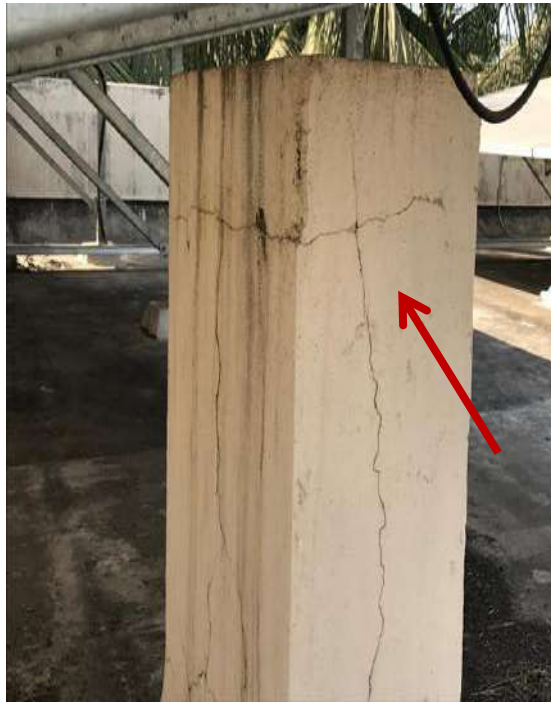
PH NO-19:-Photograph showing crack and de bonded concrete cover on pedestal column .

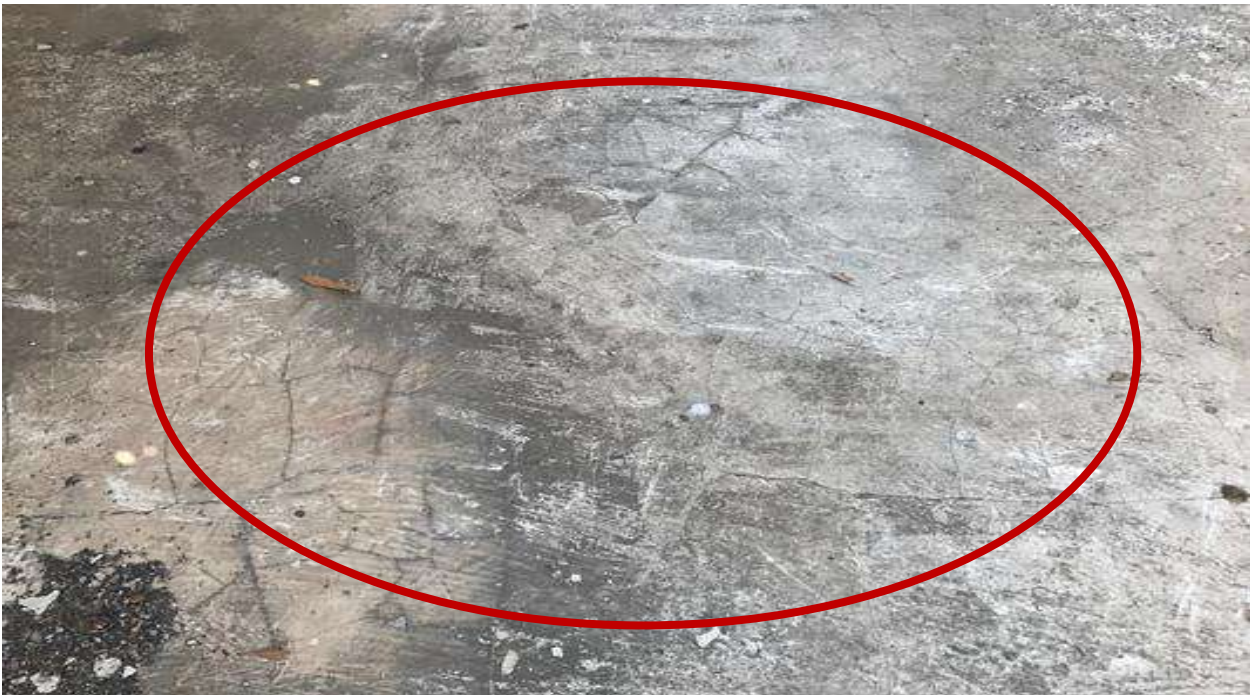
PH NO-20:-Photograph showing crack and de bonded concrete cover on IPS waterproofing.

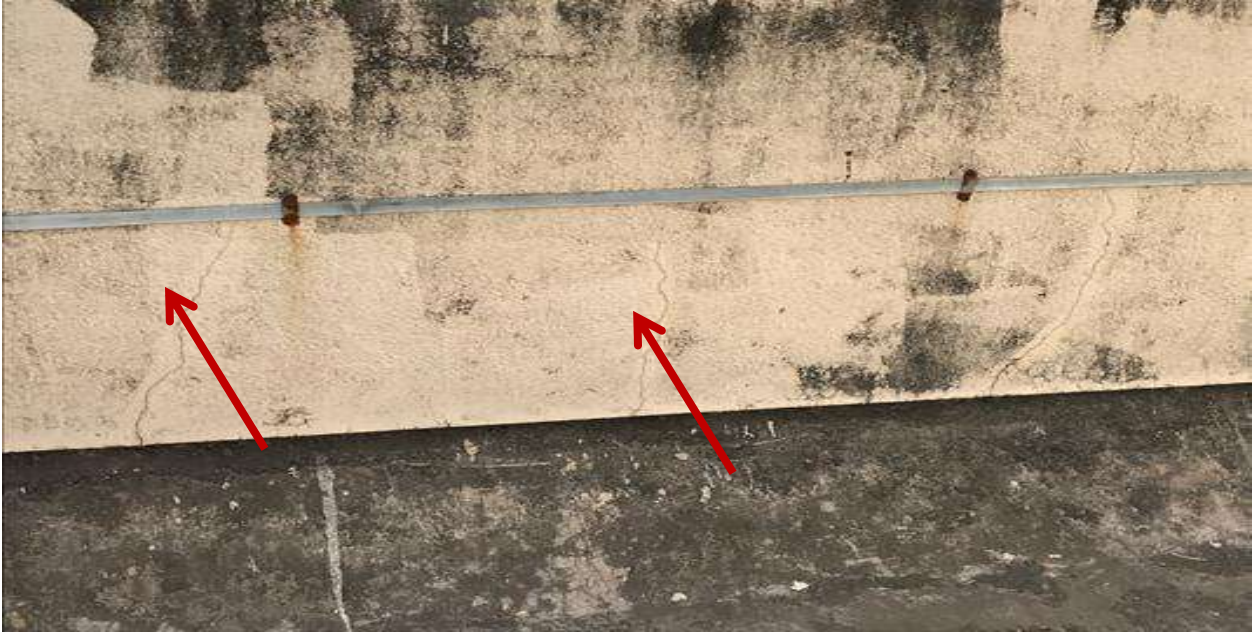
PH NO-21:-Photograph showing plaster crack on parapet wall.

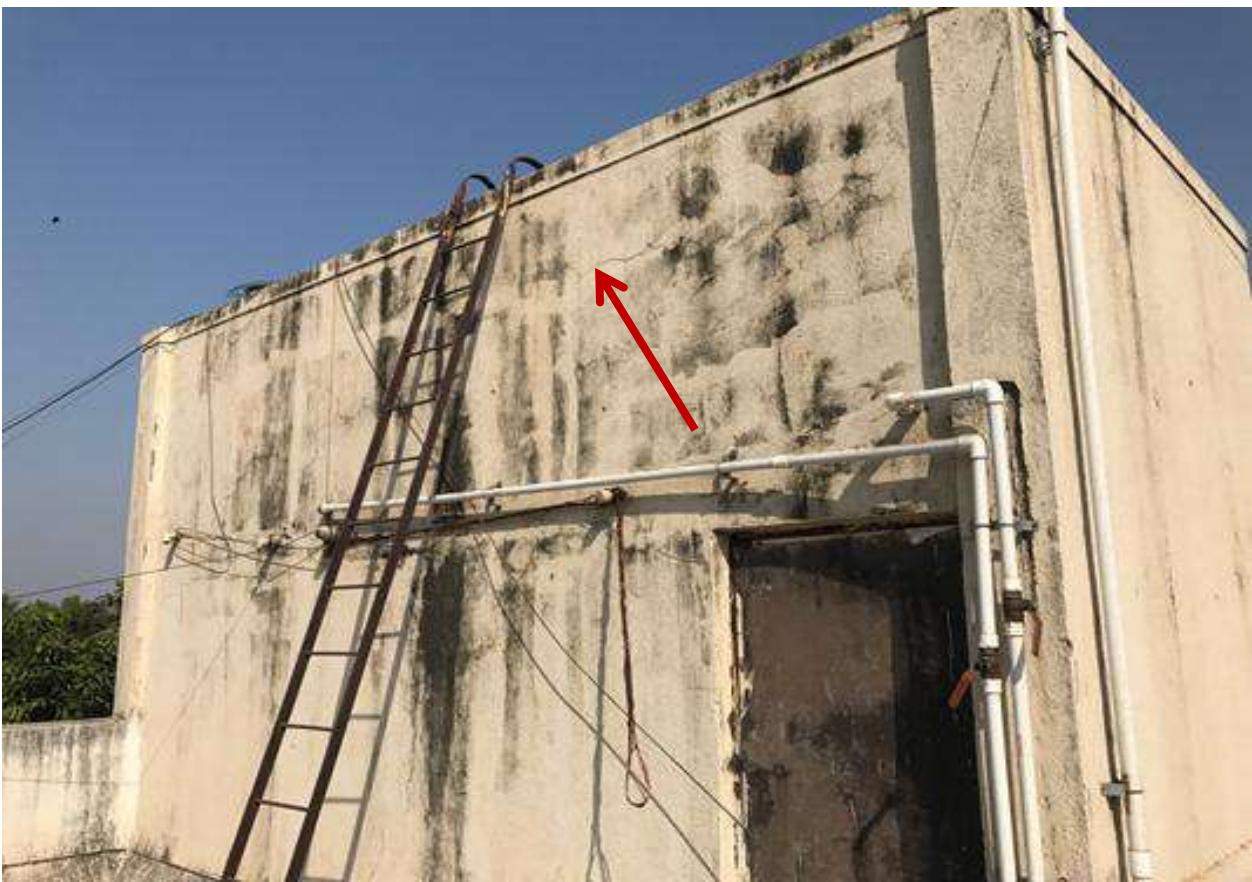
PH NO-22:-Photograph showing plaster crack on overhead tank wall.

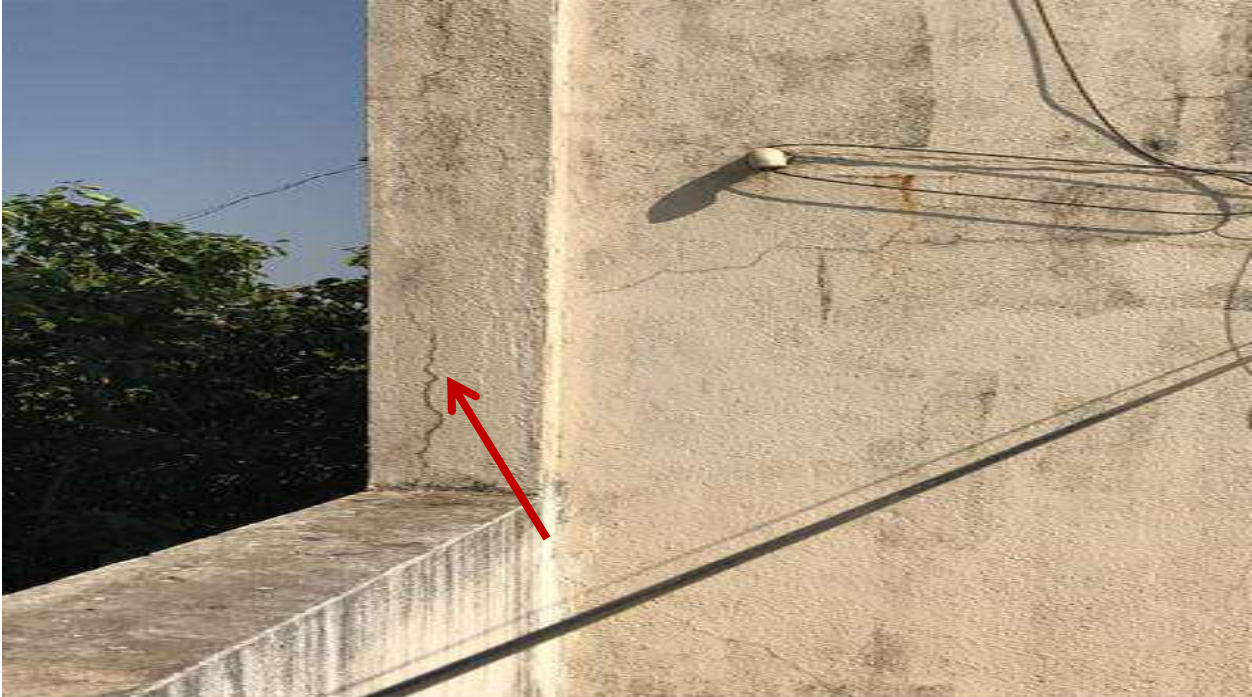
PH NO-22:-Photograph showing crack on column overhead tank .

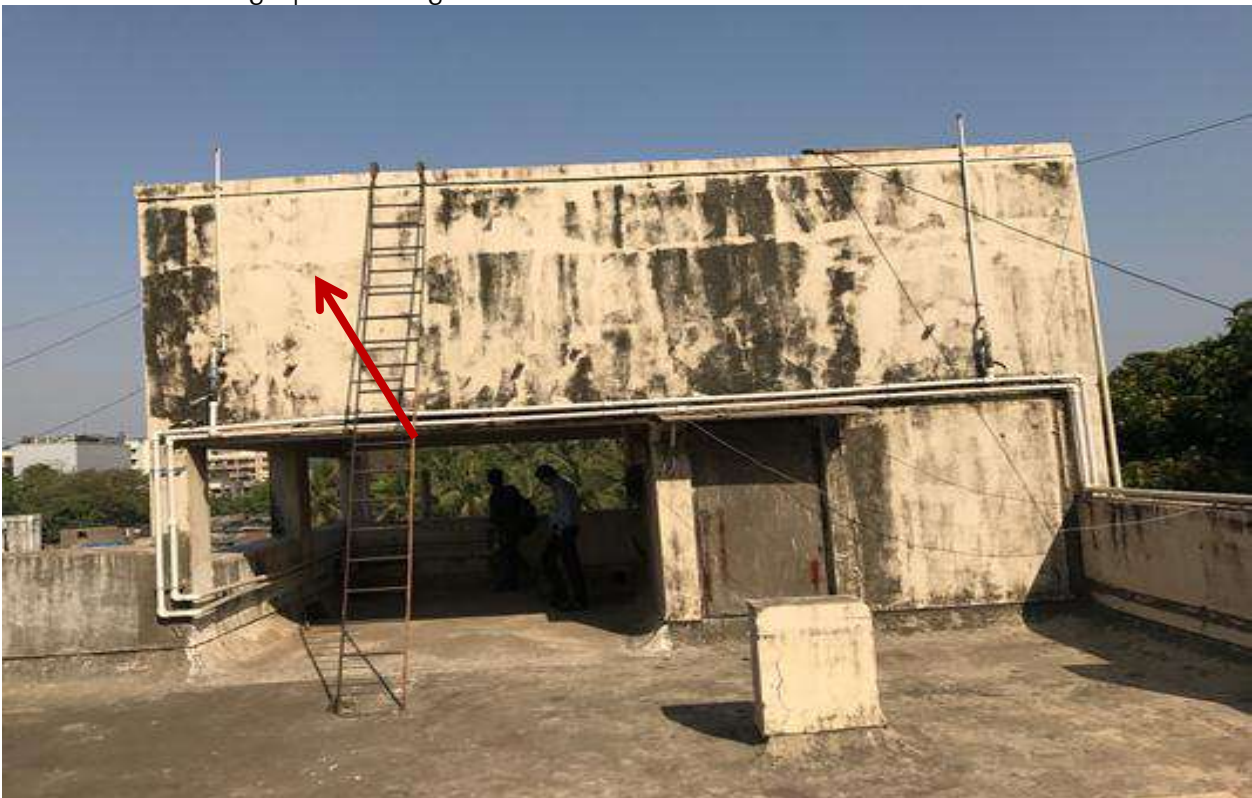
PH NO-23:-Photograph showing plaster crack on overhead tank wall.

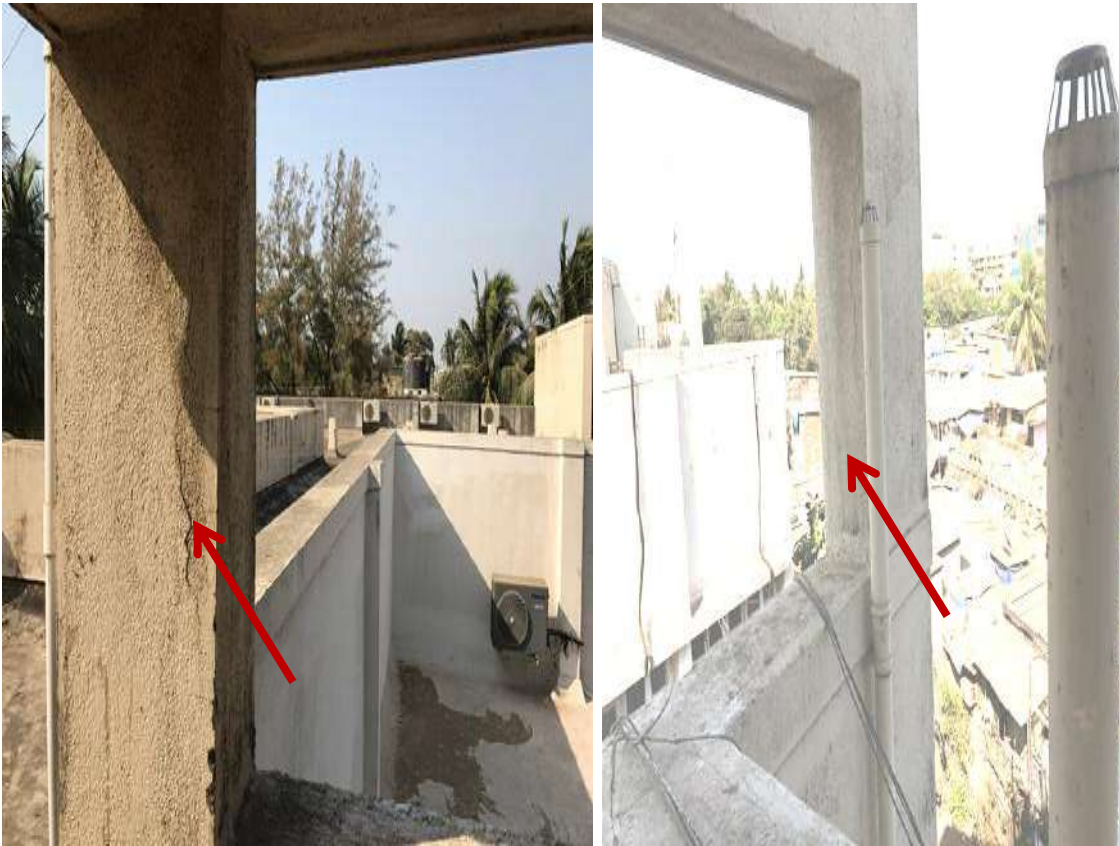
PH NO-24 & 25:-Photograph showing crack on column overhead tank.

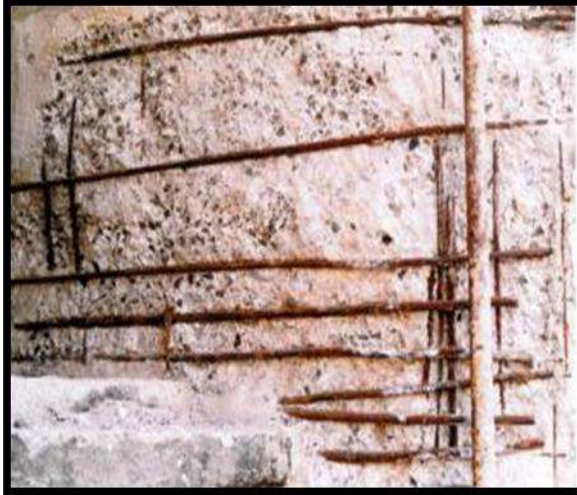
### 1. Corrosion of steel reinforcement in Concrete

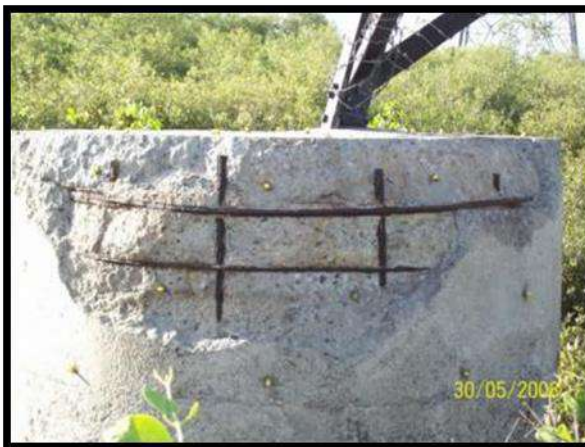
### 2. Cleaning of steel reinforcement & application of alkaline rust converting primer

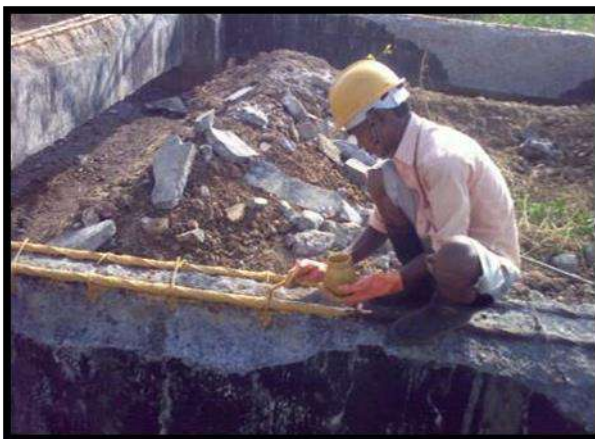
### 3. Application of IPN protective coating on steel reinforcement

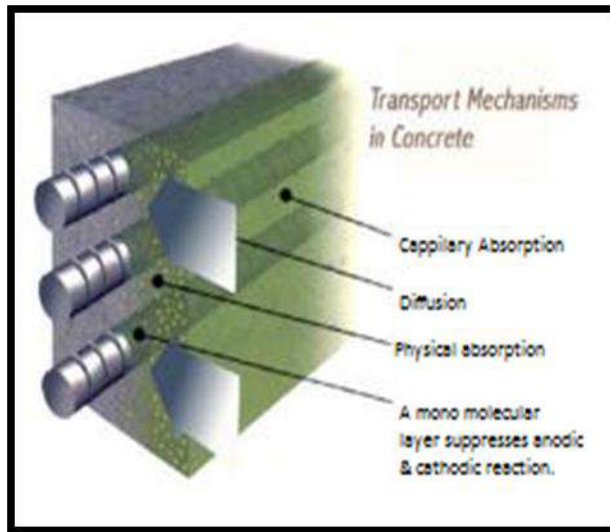
**4. Protection of unexposed steel reinforcement inside concrete by migratory corrosion inhibitor (MCI)**

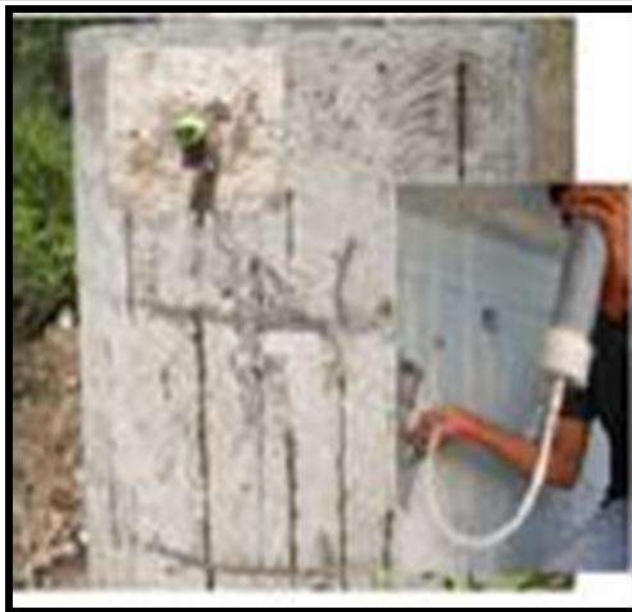
- 9. Improving core concrete strength by pressure resin grouting
- 10. Drilling holes & fixing nozzles in design grid.
- 11. Pressure grouting of resin, monomer of polymer cement slurry as per requirement.
- 12. Advantages: Penetrates even in fine cracks, Seals cracks, restores structural integrity. Good mechanical and durability properties

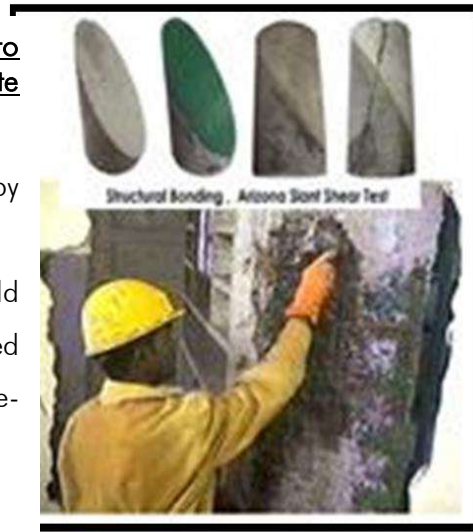
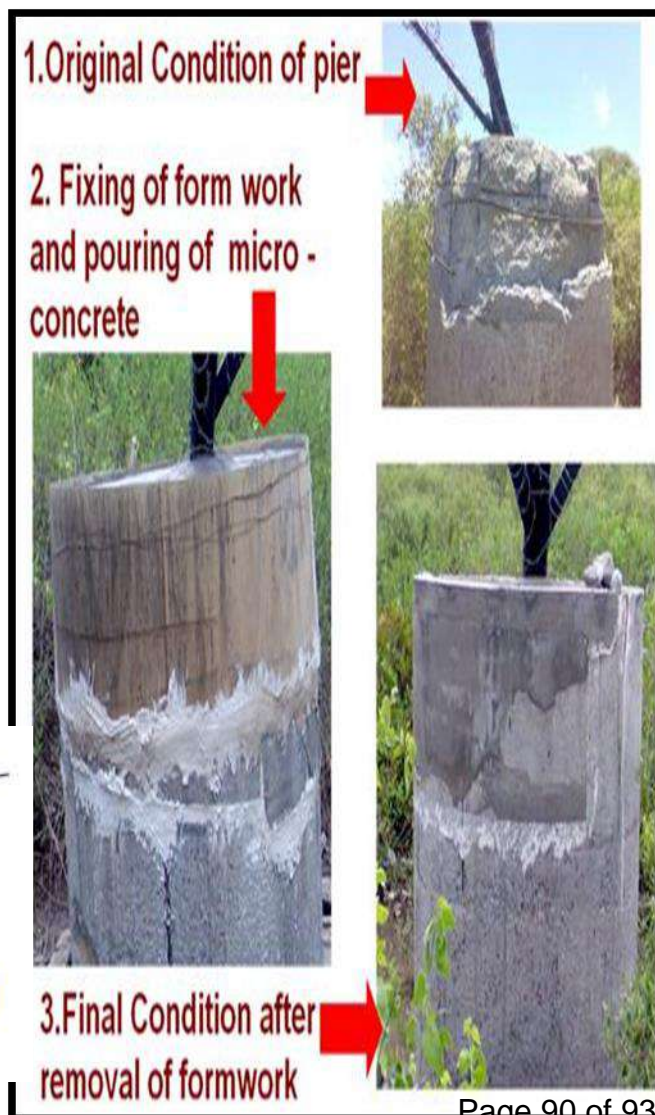
**2. Sectional reconstruction by micro concrete**

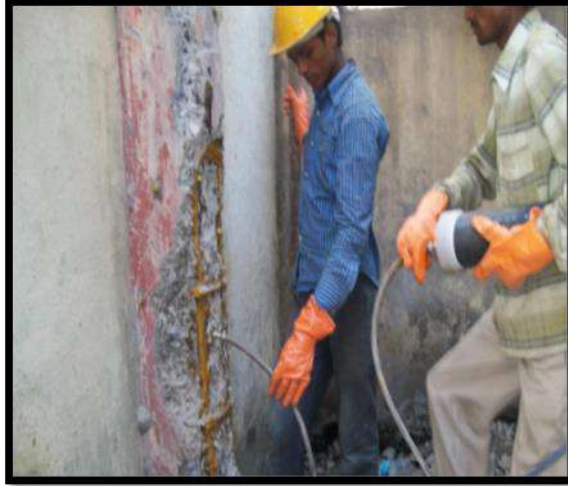
Fill the grouting gun with epoxy resin. Maintain desired pressure in the gun by air compressor; maintain the pressure at exit (3 to 5 Kg/ cm<sup>2</sup>) by monitoring pressure gauge at exit or as per consultant's instruction. Grout the material through prefixed nozzles in the structural elements still its refusal. Seal the nozzle with Epoxy putty after the refusal. Monitor leakages through other nozzles while grouting and seal them as per the requirement. Repeat the process for all the nozzles. Complete the operation within pot life of the material.
